# State Route 94 Culvert and Bridge Evaluation

In order to facilitate potential enhancements to the State Route (SR-) 94 for wildlife movement, an initial assessment was performed to identify current road undercrossings which may be suitable for wildlife movement between Rancho Jamul Ecological Reserve (RJER) and Hollenbeck Canyon Wildlife Area (HCWA), between Otay Lakes Road at the South end of RJER and the Jamul Indian Village at the North end.

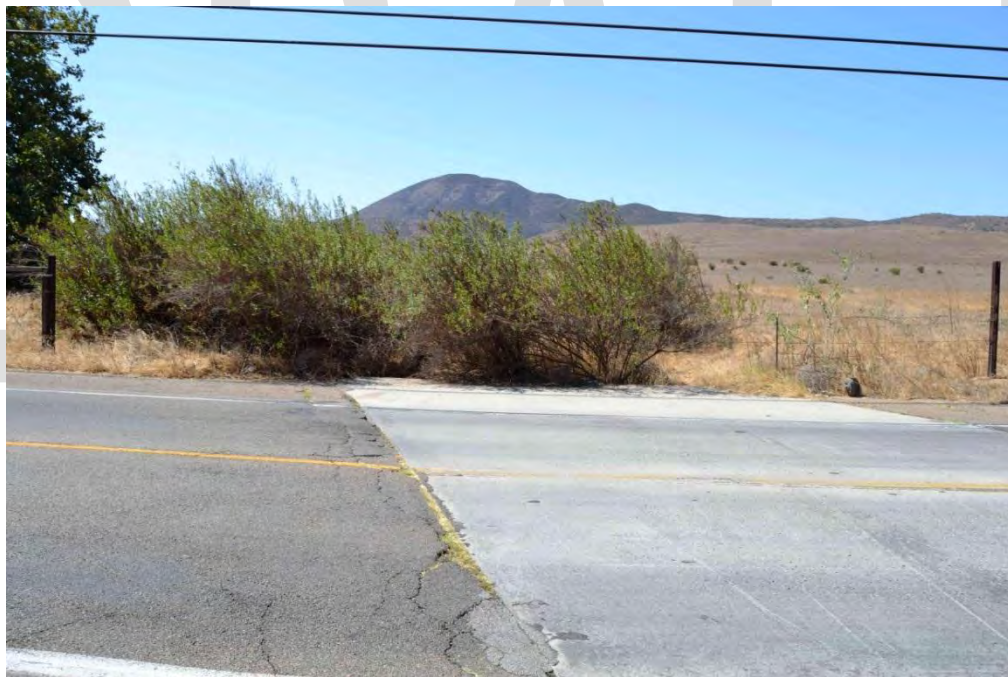
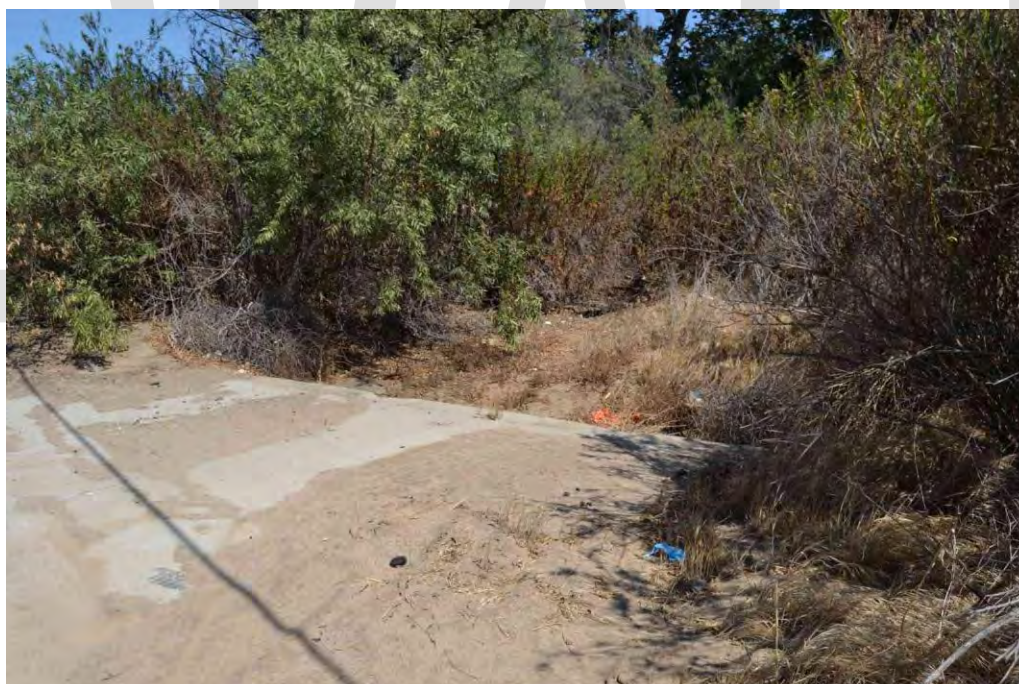
Figure 2. Looking west into RJER.

- a. Existing Conditions: The “Daley Dip” is an Arizona style crossing with three 3-foot diameter RCP pipes beneath the roadway. Fencing is a three strand barbed wire fence subject to storm flow damage.

- b. Wildlife Evaluation: Wildlife crosses at this location at grade because sediment fills the culverts following most storm events and is generally maintained only immediately prior to a storm event. Numerous road kill events at this location both documented and observed prior to establishment of the road kill data base.

- c. Safety Evaluation: Traffic slows for the dip crossing and often vehicles will tailgate slower vehicles. During storm events water flows over the roadway slowing traffic further, and occasionally stops traffic during heavy flood events. Vehicles may also swerve to avoid striking wildlife.

- d. Recommendations: Raising the roadway to eliminate flooding would also allow better wildlife crossing if properly designed. Installation of a bridge would be the preferred alternative to minimize encroachment into habitat, although large culverts would provide a suitable crossing as well.

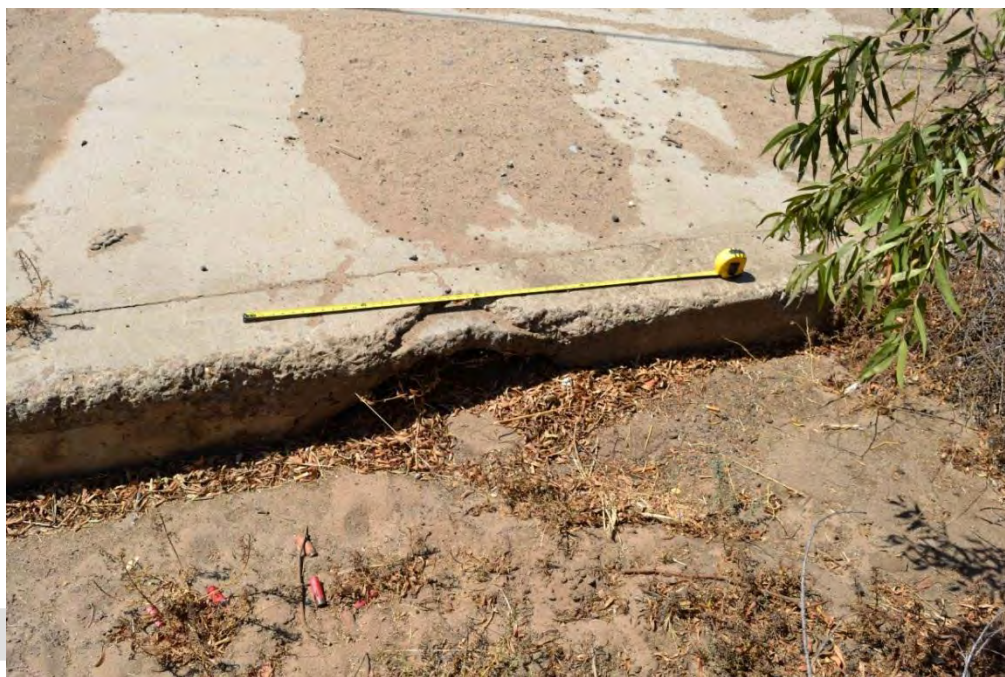
Figure 3. Looking west from HCWA. Note 3 foot diameter pipes almost entirely buried in sediment.

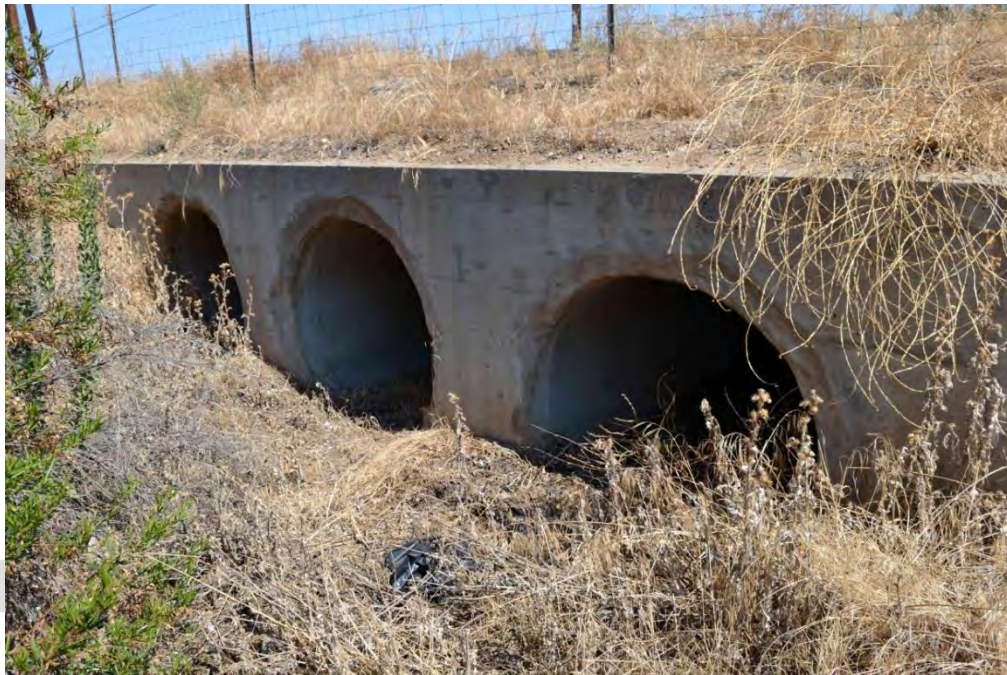
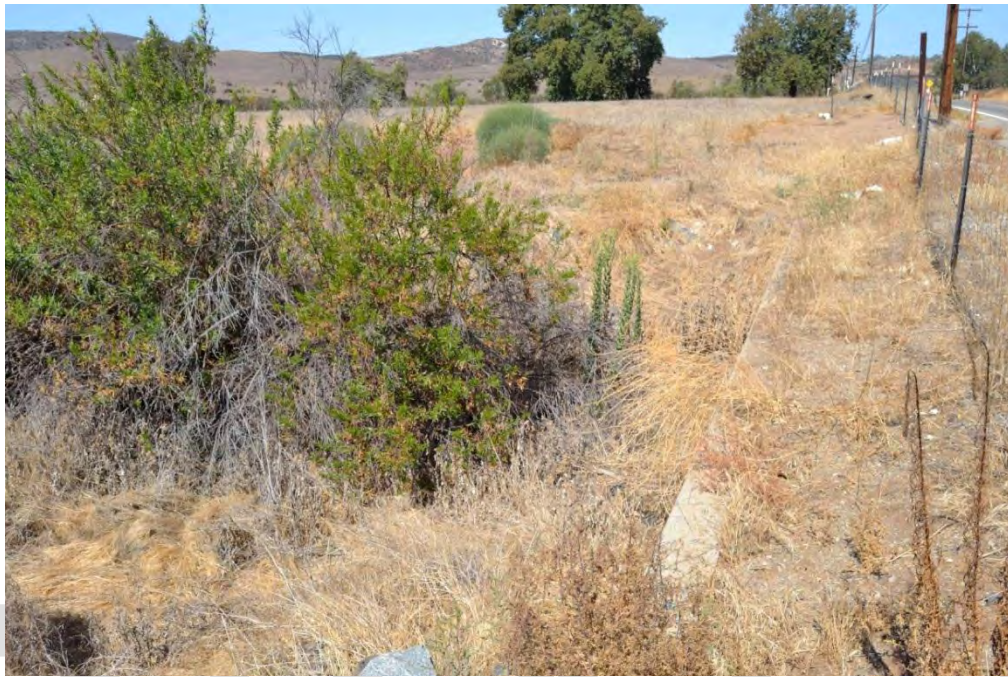
Figure 5. Looking east from RJER.

- a. Existing Conditions: Three 4 foot diameter side by side culverts. Fencing is a 4 foot tall field fence topped with a single strand barbed wire.
- b. Wildlife Evaluation: These culverts function somewhat as a small animal crossing. Camera traps show use by long tailed weasels and rabbits. Coyotes still tend to cross at grade, and improvements to the culvert approaches could increase use.
- c. Safety Evaluation: Keeping wildlife off of the highway could prevent accidents caused by swerving to avoid wildlife.
- d. Recommendations: Improve habitat on both sides of the roadway and maintain the culverts to provide clear approaches to the crossing.

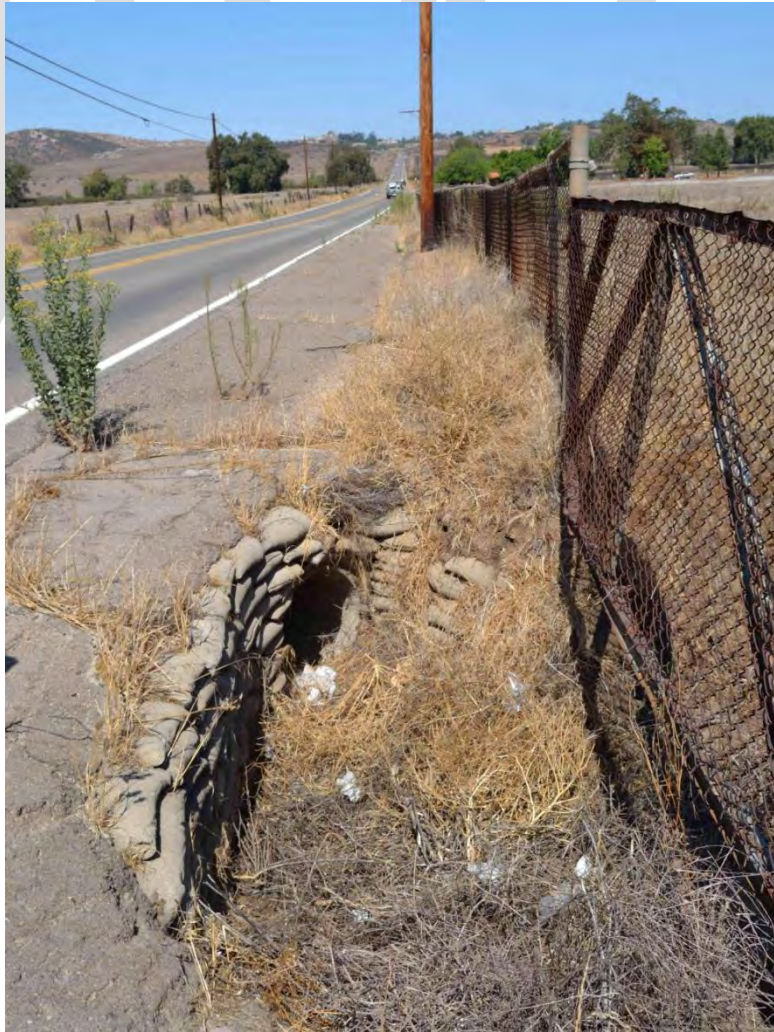
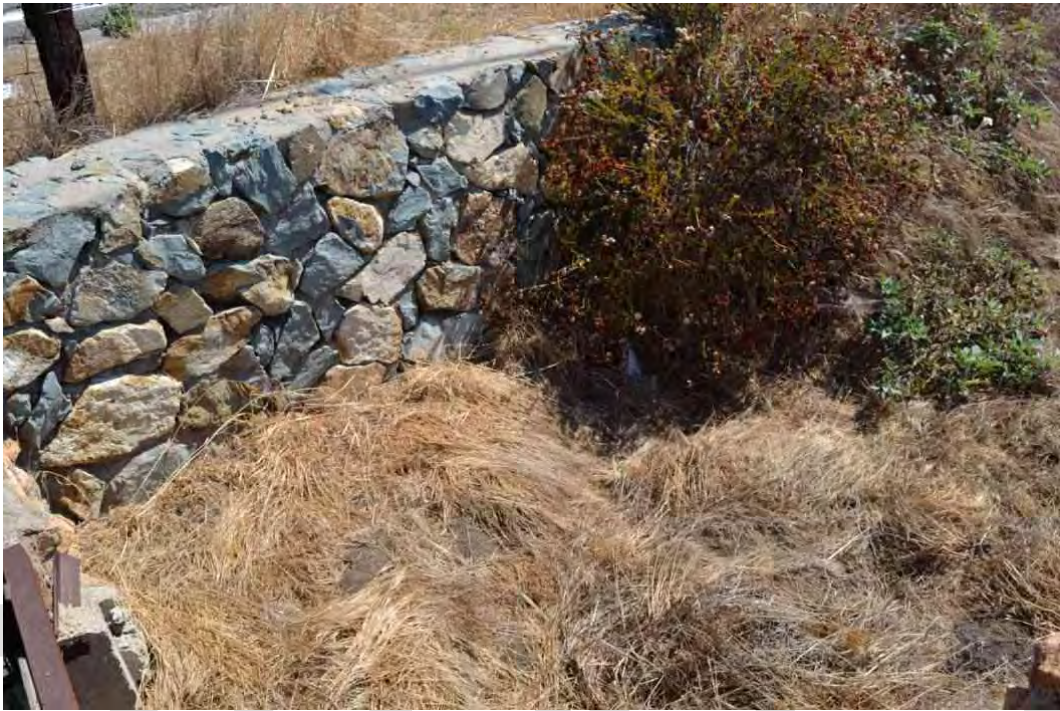
Figure 7. Looking north towards Rancho Jamul Road.

- a. Existing Conditions: a 24 inch culvert partially blocked with sediment and brush. Fencing is a 4 foot tall chain link fence with a gap on the bottom edge to allow debris flow.

- b. Wildlife Evaluation: This culvert does not provide a functional crossing as the upstream entrance is within the roadway fencing, fencing does not direct wildlife into the culvert and the culvert is too small for most wildlife. The downstream end of the culvert is a diversion box which obscures visibility through the culvert, and often fills with sediment and debris.

- c. Safety Evaluation: Keeping wildlife off of the highway could prevent accidents caused by swerving to avoid wildlife.
- d. Recommendations: Remove the diversion box and redirect the flows to the adjacent field. A swale from historic flows still exists through the grassland. Enlarge the culvert to provide a small/medium animal crossing, extend the upstream end into HCWA and fence the approach to direct wildlife into the crossing. Improve habitat on both sides of the roadway and maintain the culverts to provide clear approaches to the crossing.

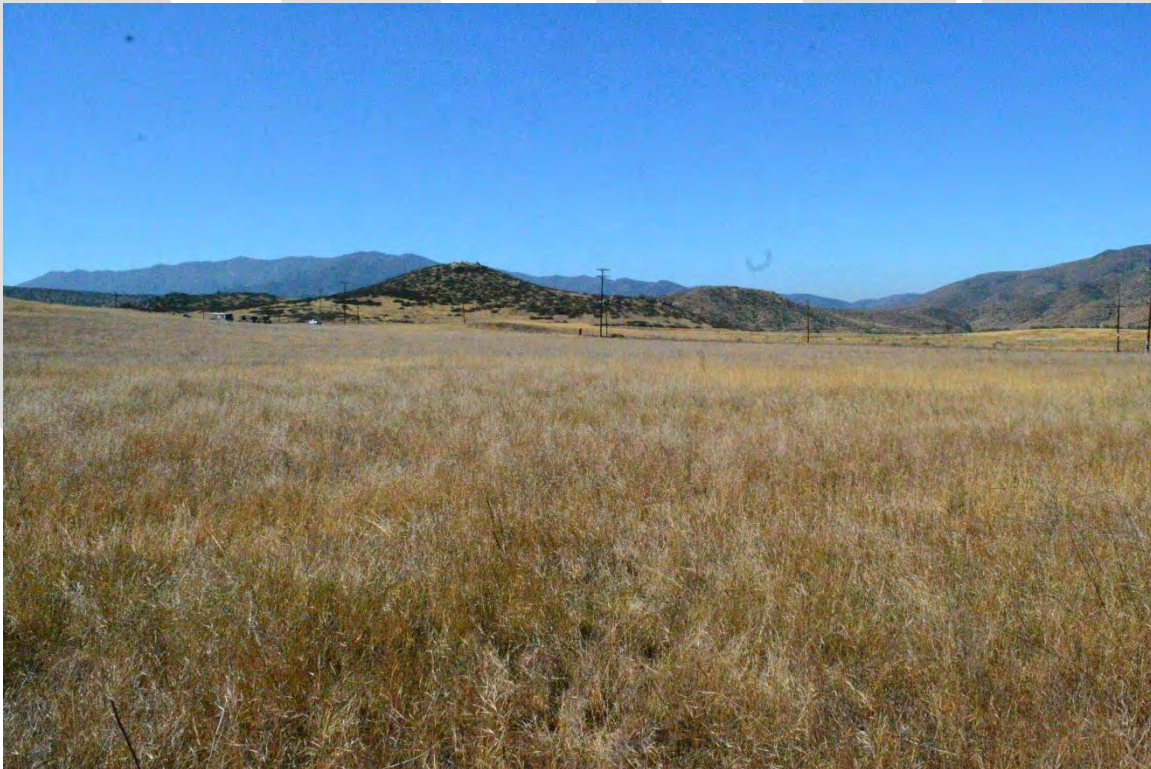
Figure 9. Looking west towards RJER.

- a. Existing Conditions: A segment of undulating roadway approximately 750 feet north of the RJER main gate without culverts or other crossings. Wildlife currently crosses the roadway at grade, and well developed game trails exist to the east and west. The fence is a six-foot chain link fabric recently repaired by CDFW.

- b. Wildlife Evaluation: Wildlife previously crossed the roadway through gaps in the fencing caused by multiple vehicle accidents. Wildlife is likely to continue to attempt to cross the road in this location as a major water source exists on RJER in this area. A safe crossing should be installed, likely a dual basin undercrossing as the land is relatively flat on both sides of the highway.

- c. Safety Evaluation: CDFW has repaired these fences numerous times following vehicle accidents. The undulations in the roadway hide oncoming traffic from those who are willing to illegally pass in this section, leading to vehicles swerving off of the highway to avoid head on collisions. Leveling the road and improving the line of sight in this section could help prevent these types of accidents.

- d. Recommendations: Installing a culvert underneath this section and leveling the roadway would improve conditions for both wildlife and for public safety.

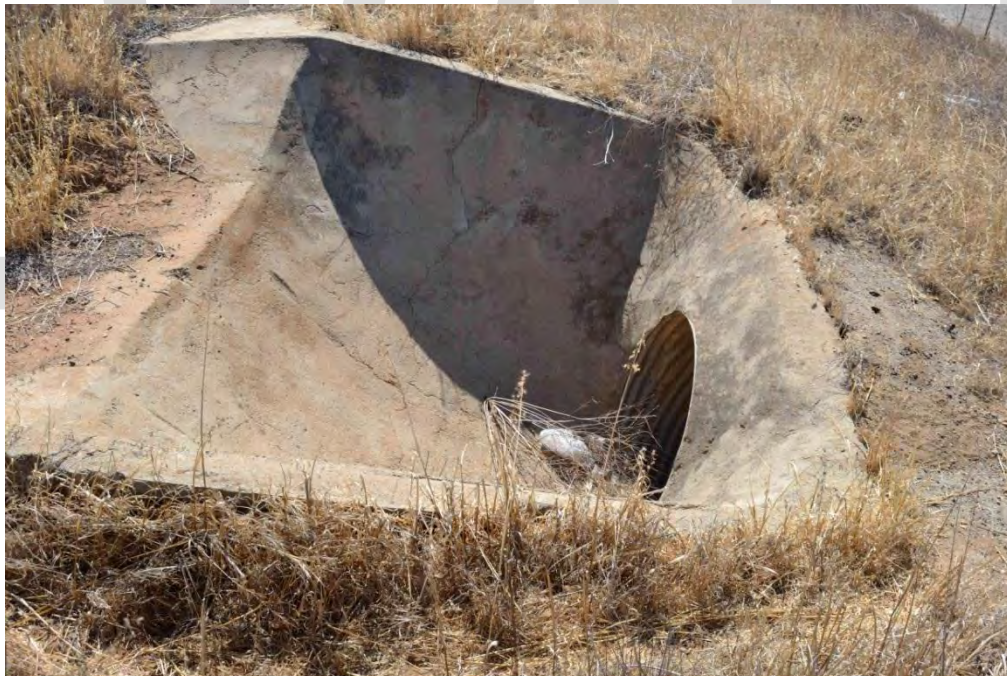
- a. Existing Conditions: A single 48 inch culvert which has a bend in the pipe somewhere underneath SR-94, with an outlet in a drainage ditch within RJER, and two inlets on either side of SR-94 consisting of grated drains, and a large inlet with steeply angled concrete sides. The fence is a six-foot chain link fabric recently repaired by CDFW.

- b. Wildlife Evaluation: Wildlife previously crossed the roadway through gaps in the fencing caused by multiple vehicle accidents. Wildlife is likely to continue to attempt to cross the road in this location as a major water source exists on RJER in this area. The existing culvert provides little if any function for wildlife.

Figure 10. Looking south. This inlet is very steep and the sides are smooth concrete.

- d. Recommendations: Installing a culvert underneath this section and leveling the roadway would improve conditions for both wildlife and for public safety. If CDFW develops a public parking area here, a slowing and turn lanes for school buses should be installed.

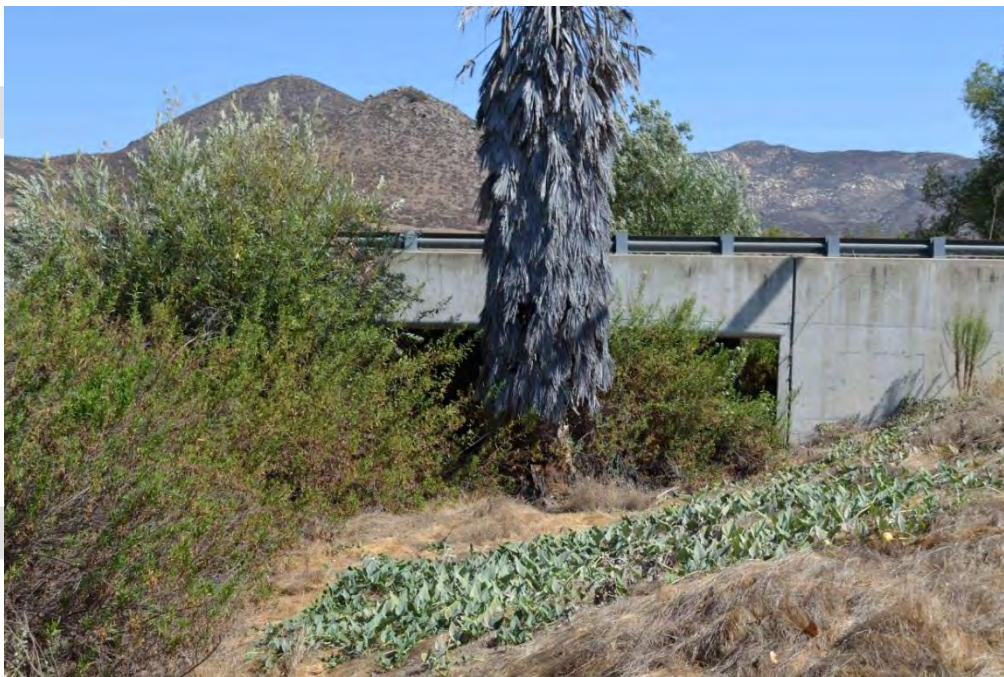
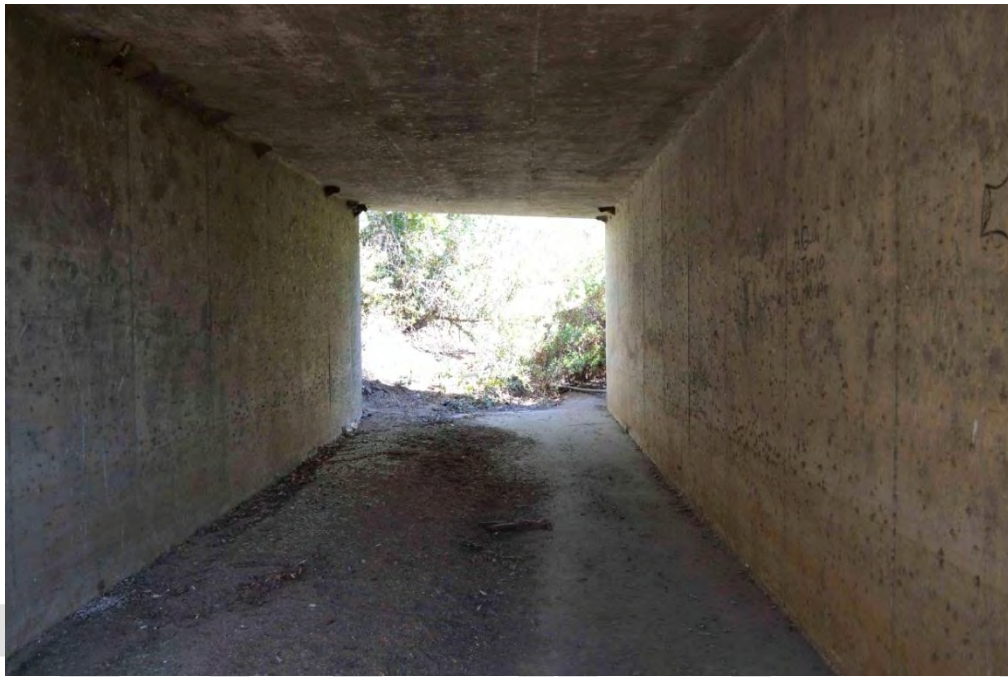
Figure 11. Looking east towards private residence.

- a. Existing Conditions: Three side by side 12'x12' culverts approximately 40 feet long. On the west side of the highway, the RJER main gate is a six foot tall steel gate surrounded by five foot chain link topped by 3-strand barbed wire. On the east side there is a four foot tall chain link fence across the culvert.

- b. Wildlife Evaluation: A bent fence post allows wildlife to move through the culvert but is limited to small and medium mammals.
- c. Safety Evaluation: This is an access point for visitors to the reserve including school buses. Traffic often is traveling very fast and close. There has been a least one fatal accident at this location.

- d. Recommendations: Creation of a slowing and turn lanes at this location would improve safety for the public and staff. Removal of fencing on the east side of the culverts would allow larger wildlife to move through, however the upstream channel restricts movement and should be returned to a natural channel where possible. This property is currently privately owned.

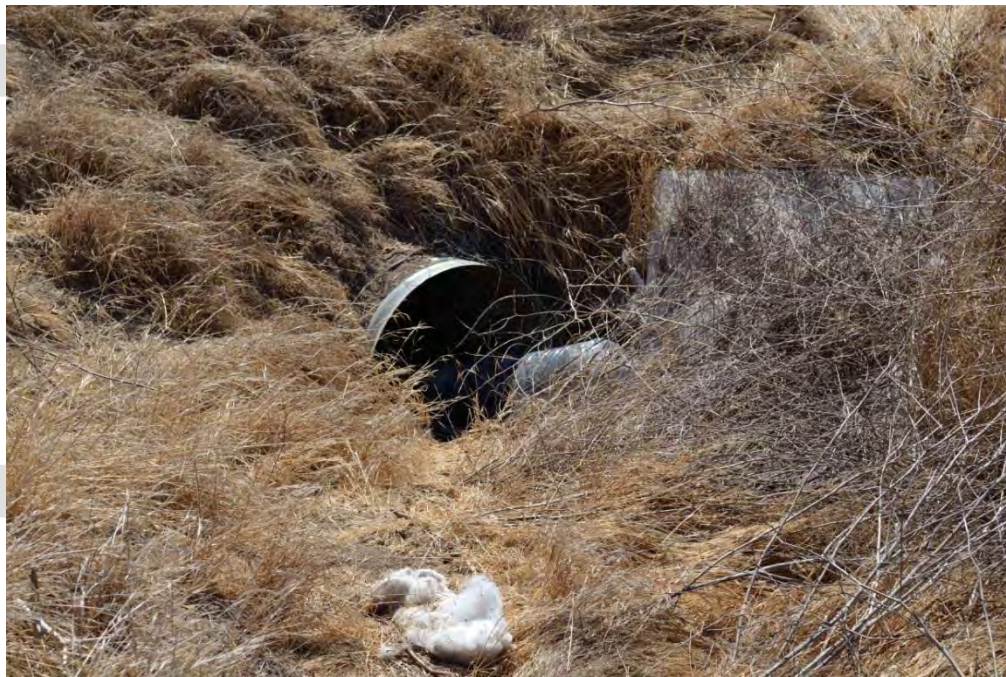
- a. Existing Conditions: A single 24" culvert approximately 80 feet long with significant vertical drop on the eastern end. The culvert discharges into the gully at the bottom of the slope on the east side of the highway. Fencing is four foot tall field fencing partially buried and topped with three strand barbed wire.

- b. Wildlife Evaluation: This culvert is small and has a steep drop through a very long pipe. It is non-functional.
- c. Safety Evaluation: This is the beginning of the passing zone. Traffic is often traveling at a high rate of speed in either direction while attempting to complete a pass.

Figure 13. Looking east at culvert set eight feet below road surface

- d. Recommendations: Placement of an over or an undercrossing at this location would greatly improve wildlife crossing opportunities and connect RJER to HCWA in a significant movement area. The turnout is a large fill slope with enough space underneath the roadway to install a large mammal crossing without significant modification of the road elevation.

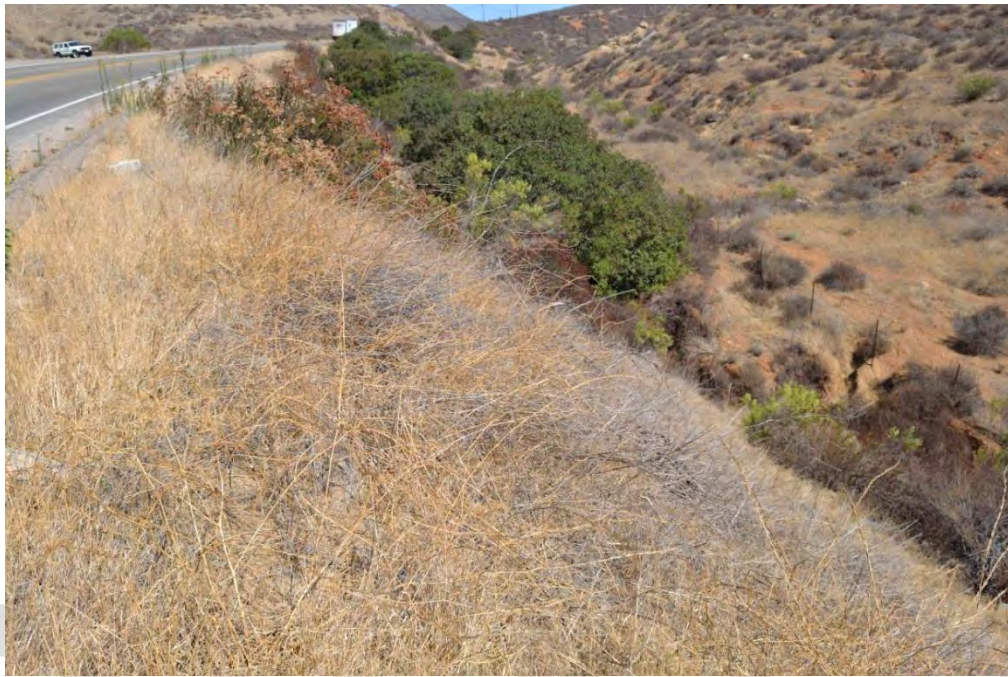
**Figure 14. Looking northeast. The culvert outlet is at the bottom of the slope. The truck on opposite side of the road is above the opening to the culvert (figure 4) on the west side.**

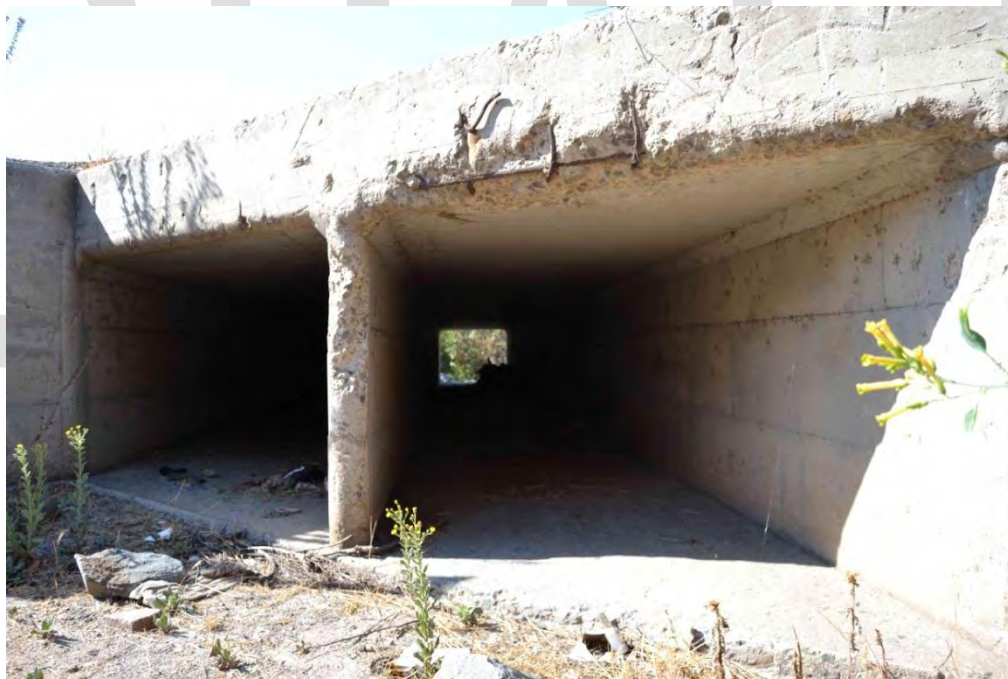
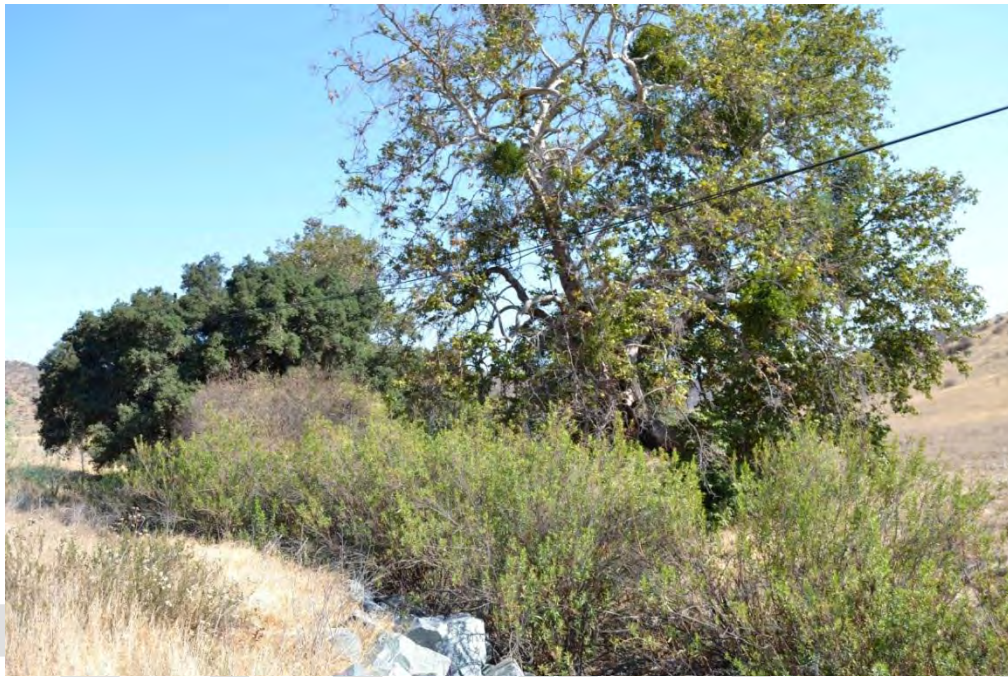
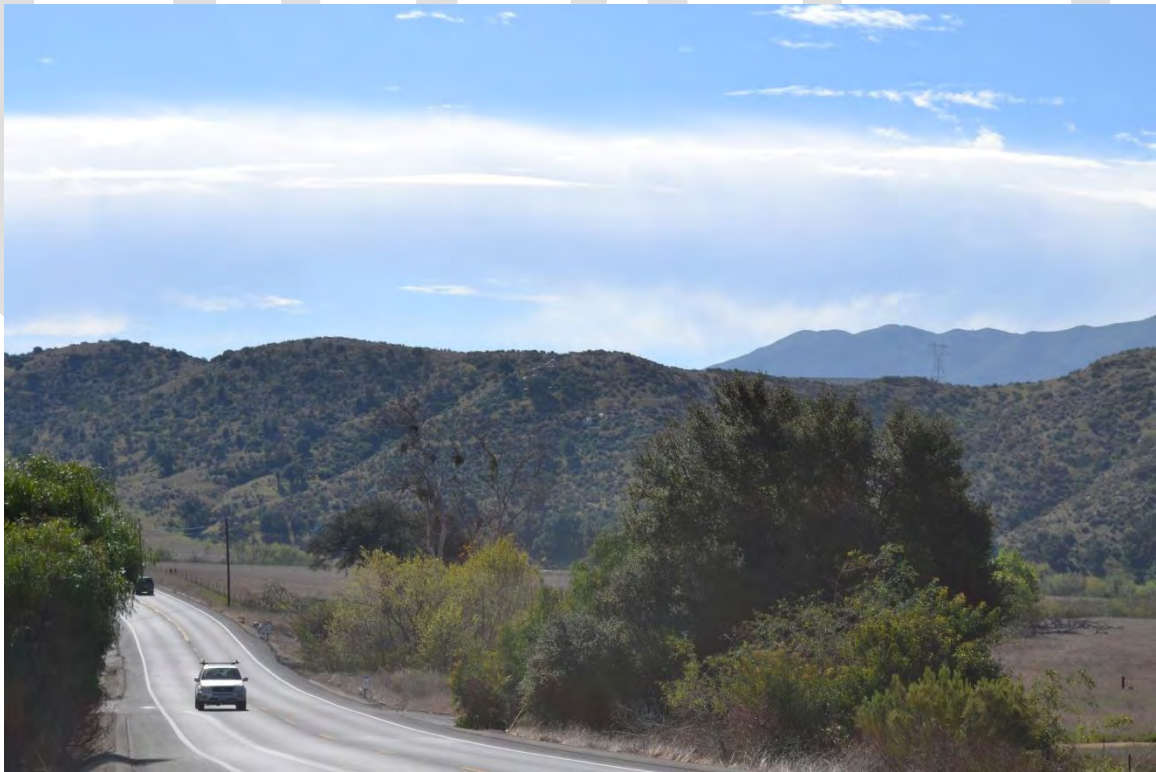
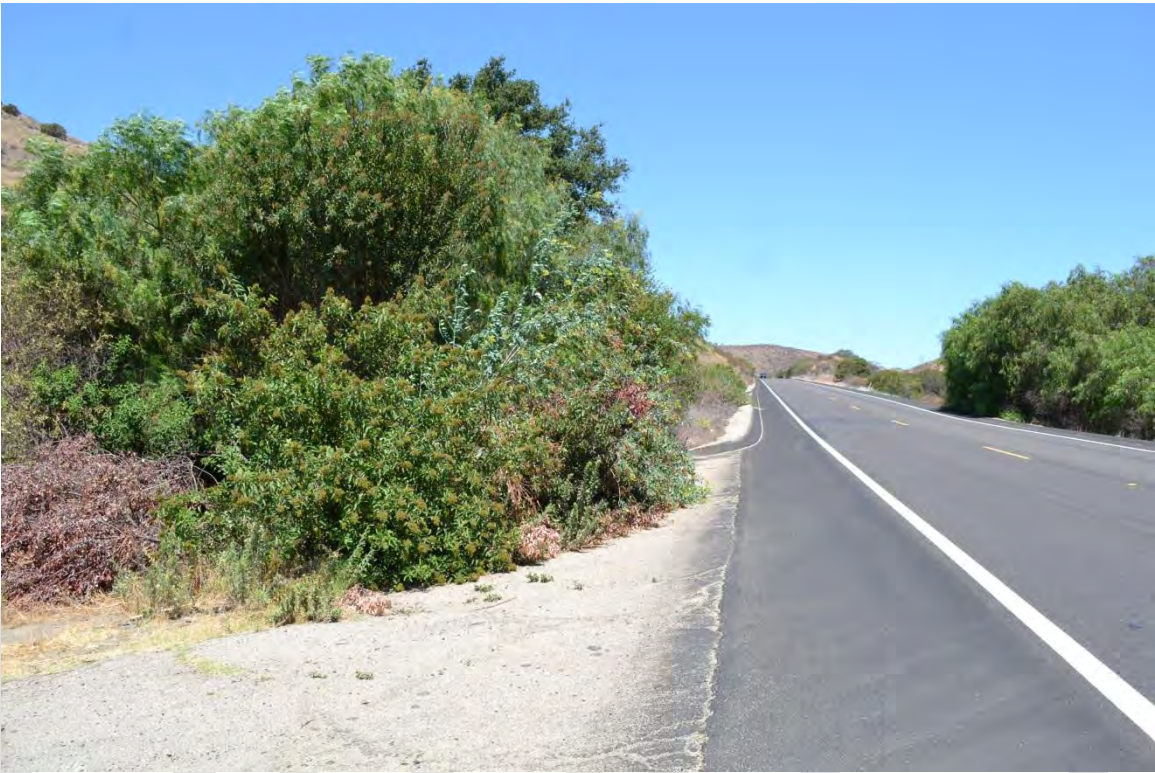
Figure 15. Looking west from HCWA

- a. Existing Conditions: two 44 foot long side by side 5x5 foot culverts connect the good riparian habitat on either side of SR-94. Fencing is composed of three strand barbed wire.

- b. Wildlife Evaluation: These culverts provide small/medium animal crossing, however a sharp drop on the downstream end of the culvert limits the suitability. The upstream end is within the Right of Way fencing and does not prevent wildlife from entering the roadway.

- c. Safety Evaluation: This is the beginning of the passing zone. Traffic is often traveling at a high rate of speed in either direction while attempting to complete a pass. Public enters the wildlife area at this location, especially during hunting season. Deceleration and turn lanes would improve safety for public and staff.

- d. Recommendations: Improvement to the entrances to the culverts to allow better access into the culverts is needed. Fencing to direct wildlife into the upstream end, elimination of the drop on the downstream end through the installation of a bench or other feature and better directional fencing would improve its use as a small/medium animal crossing.

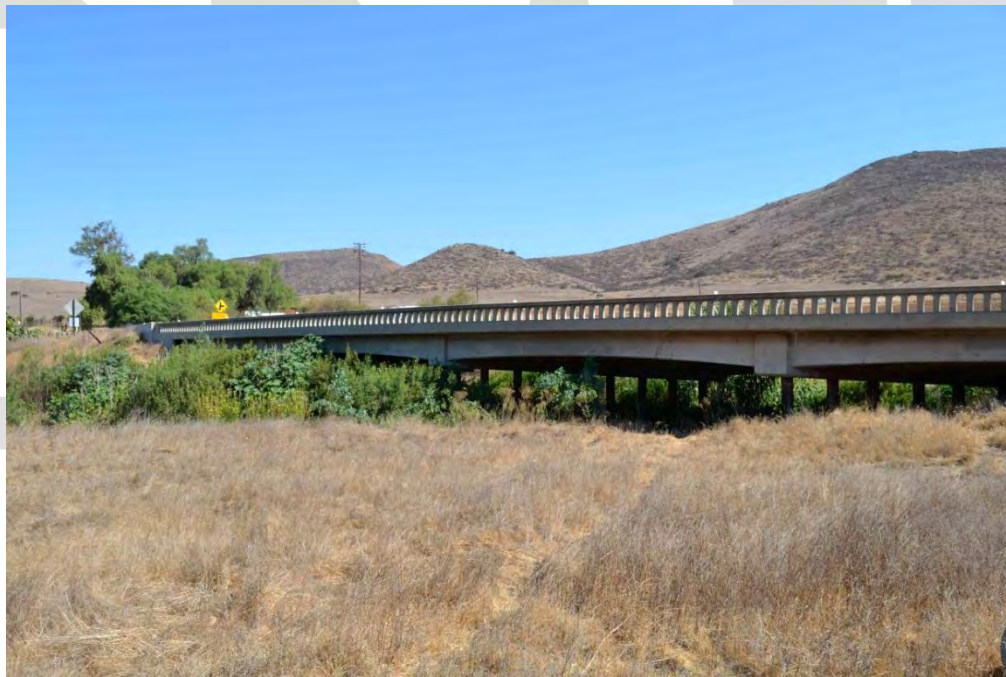
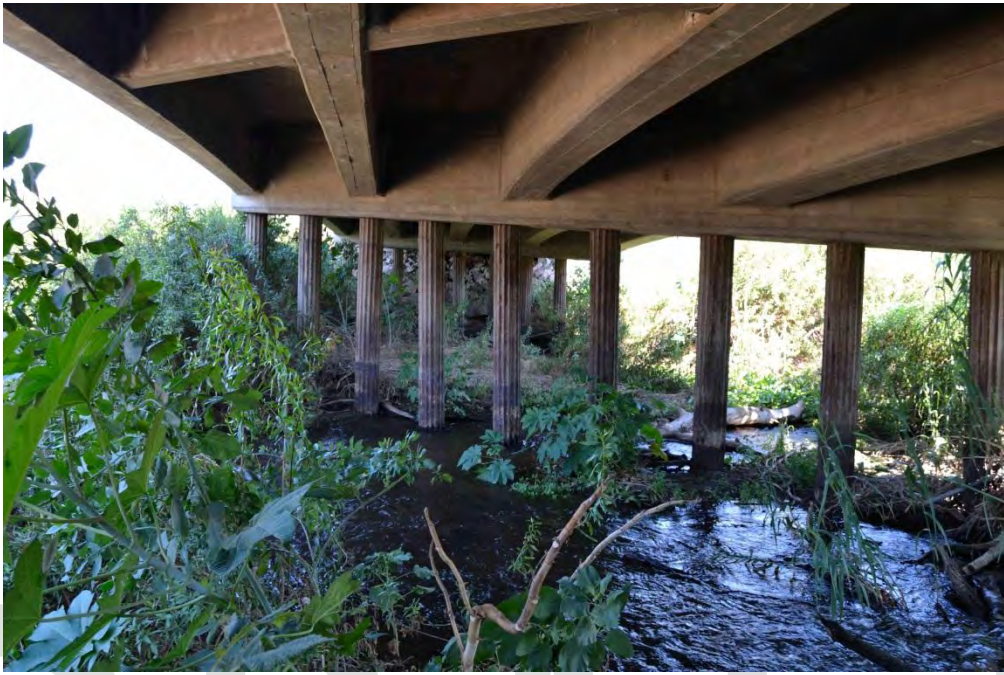
Figure 19. Looking east from RJER towards HCWA

- a. Existing Conditions: The bridge consists of 3 bents, 6-15 feet tall, with 40 foot spans between bents. Fencing is composed of three strand barbed wire. A staging area has been expanded and public is beginning to use the area as a rest stop.

- b. Wildlife Evaluation: The bridge is suitable for all species; however fencing along the road is three-strand barbed wire with numerous gaps in the length caused by vehicle accidents. Animals pass freely through the fence, and without significant upgrades to the entire fence it will not prevent animals from entering onto the roadway. The bridge also provide significant bat roost habitat for sensitive bat species.

- c. Safety Evaluation: Damaged fencing from repeated minor and major vehicle accidents allows wildlife to enter the roadway.
- d. Recommendations: Improve fencing along roadways to direct wildlife to the bridge crossing. Eliminate human access to the bridge except for necessary crews and law enforcement to reduce human disturbance to improve wildlife use.
