REVIEW OF REGIONAL HABITAT LINKAGE MONITORING LOCATIONS

Multiple Species Conservation Program

January 2003

California Department of Fish and Game
NCCP Local Assistance Grant #P0050009

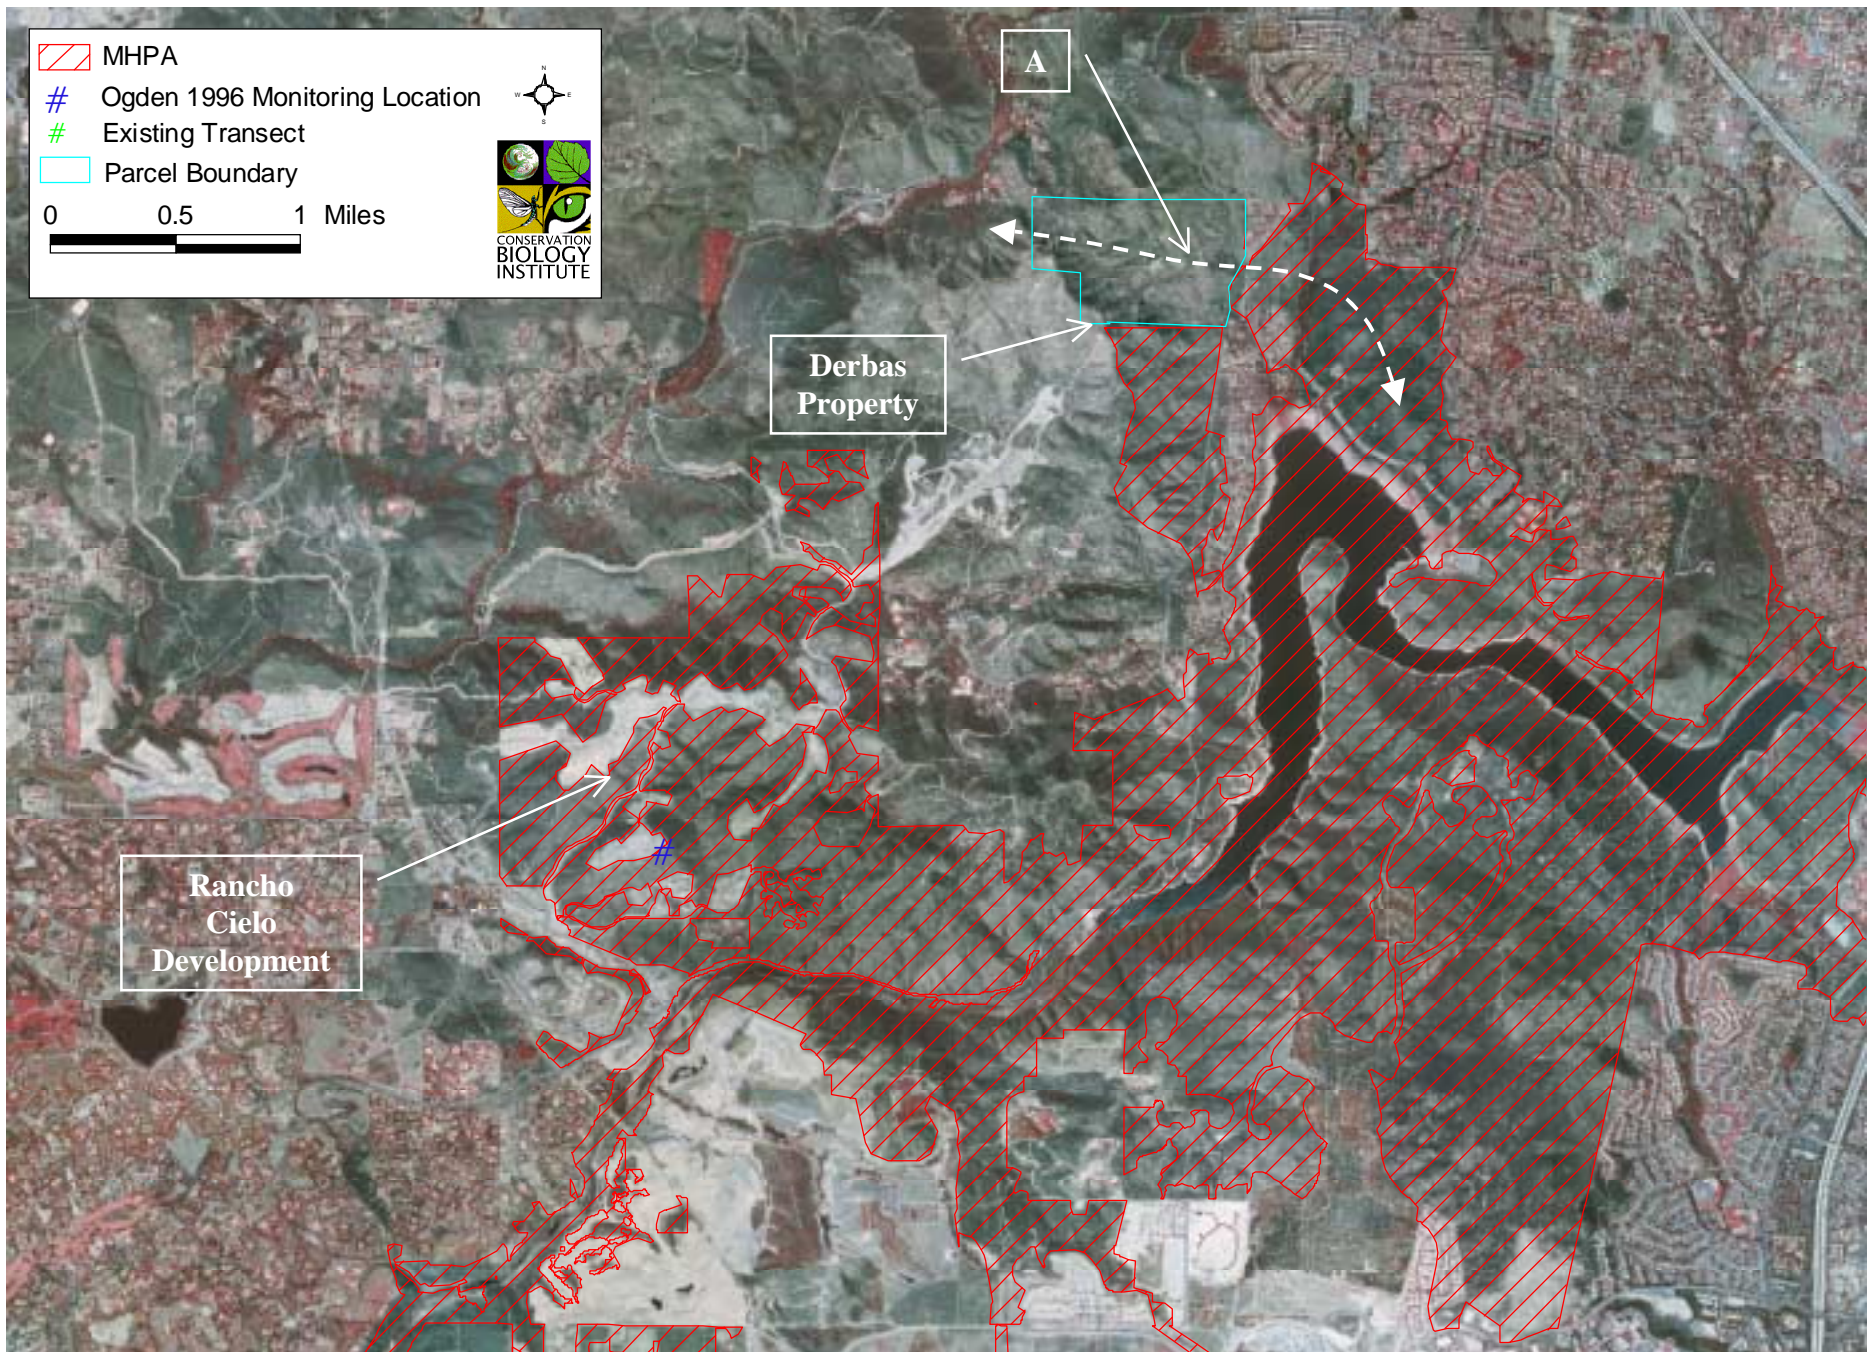
Figure L-1. Rancho Cielo - San Dieguito River. The site-specific monitoring location on the Derbas Property (A) has not been identified.

Alternative Location. Wildlife movement between the San Dieguito River Valley and the MHCP could be monitored on the Derbas property, which was recently purchased for conservation by the San Dieguito River Valley Conservancy and is part of the Escondido Subarea Plan of the MHCP. It is hypothesized that wildlife using the open space bordering Lake Hodges could cross Del Dios Highway and then move up the canyon on the Derbas property (Figure L-1, Location A). CBI recommends monitoring at this location.

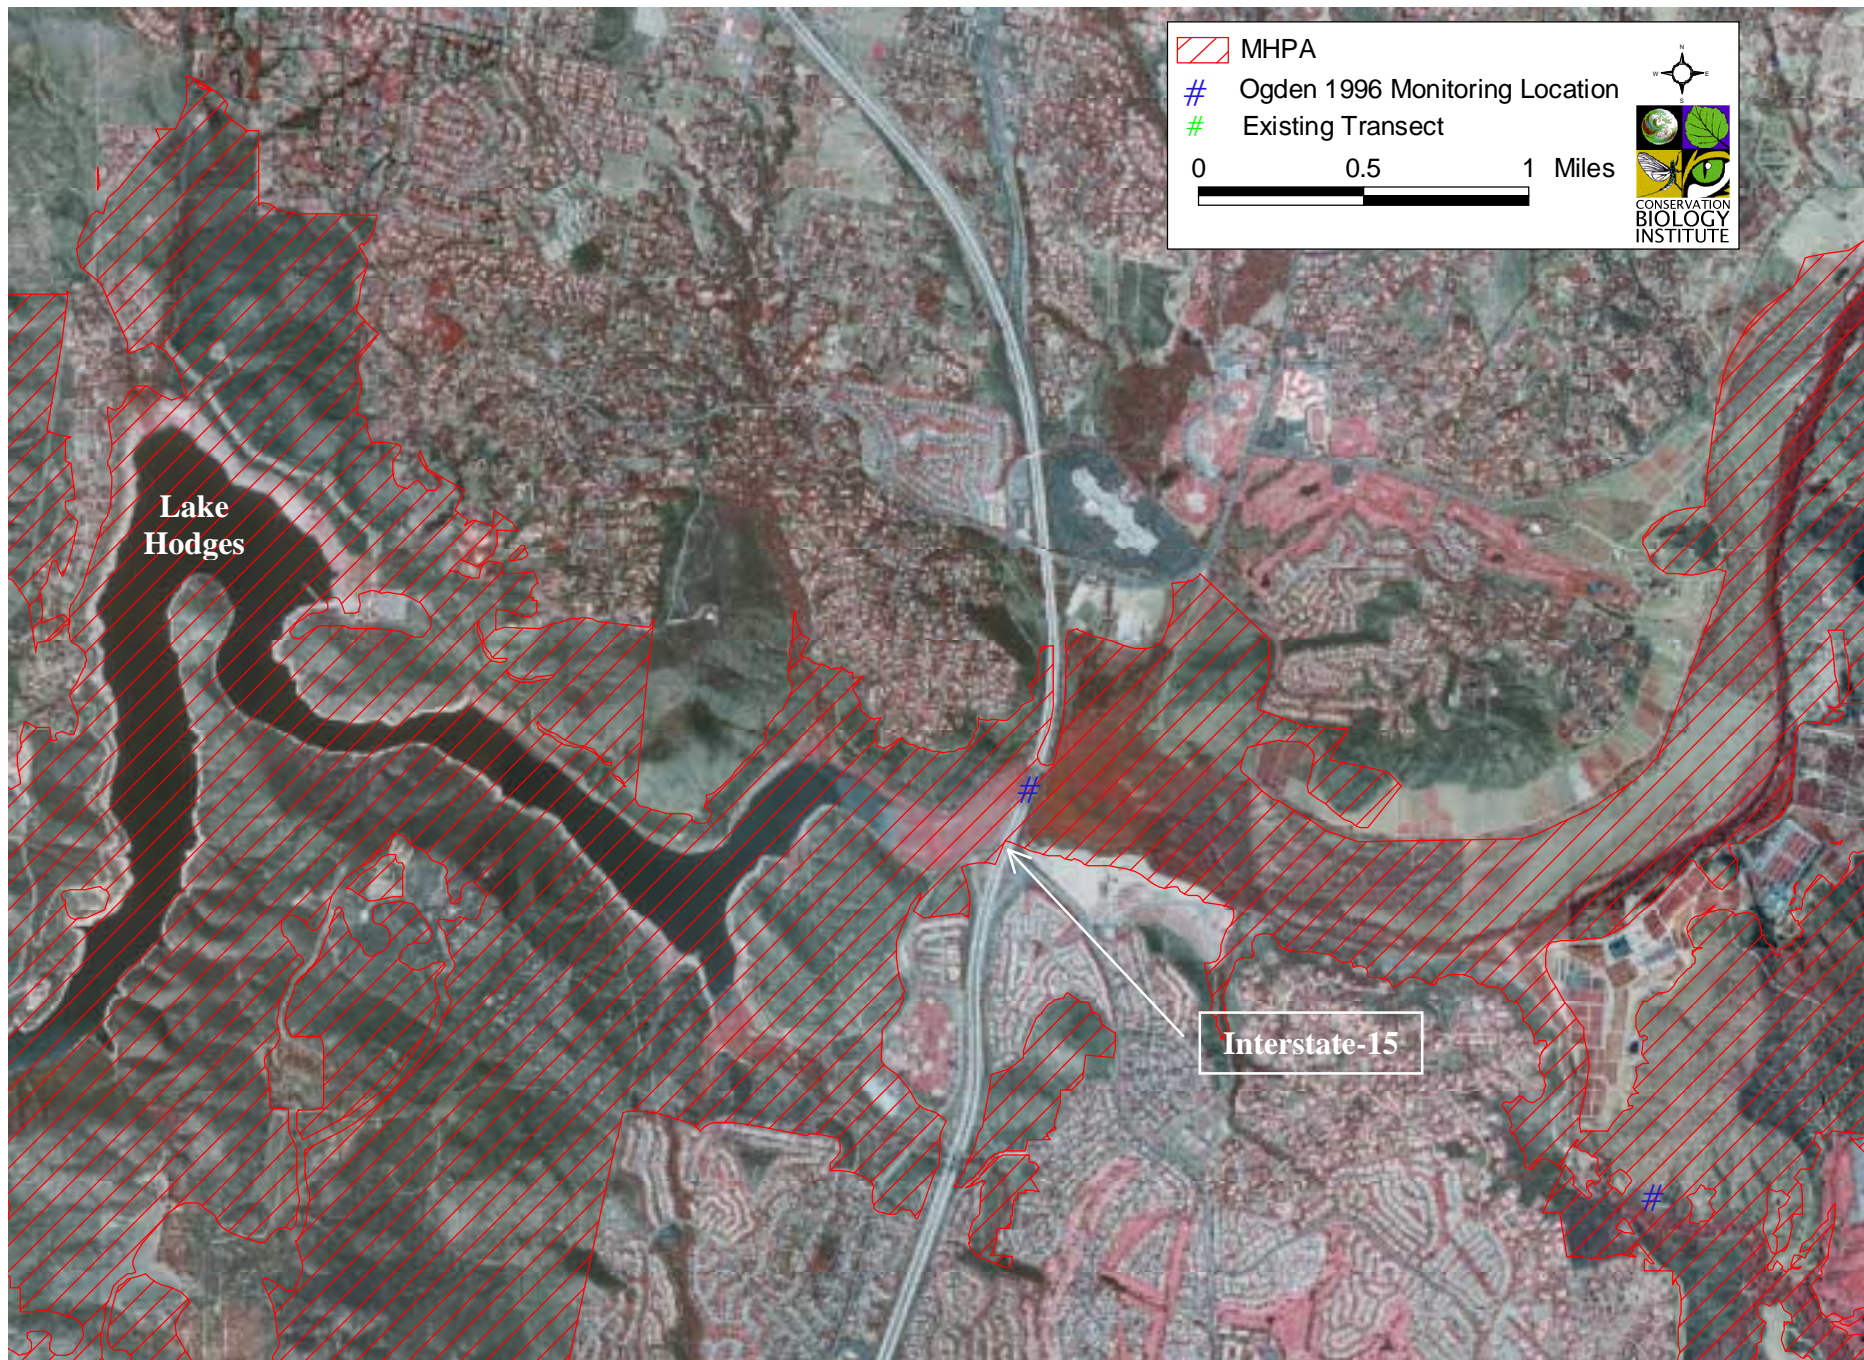
Figure L-2. Lake Hodges – San Pasqual Valley at I-15 bridge.

transition into adjacent open space areas outside of the Caltrans right-of-way. The paths could be vegetated along the margins to provide cover. Such design modifications would be a very small fraction of overall project costs and would greatly improve the wildlife corridor function of this chokepoint. CBI recommends these newly created paths under the new bridge for corridor monitoring, once the bridge is completed (Figure L-2).

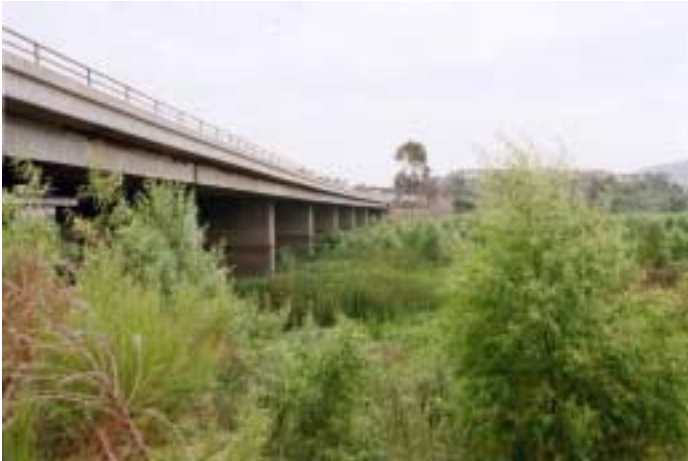
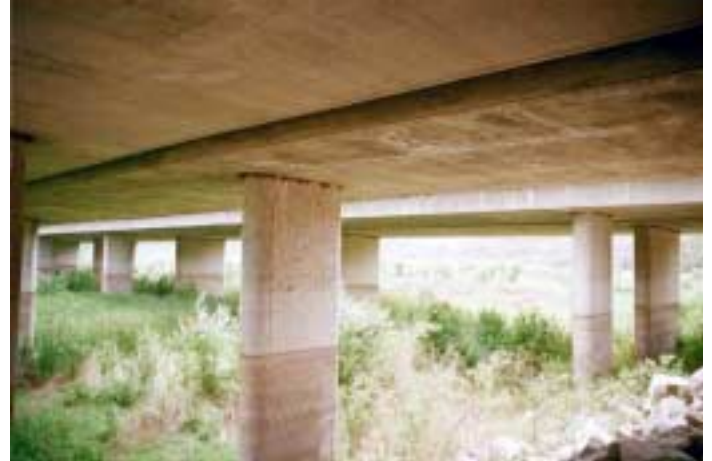
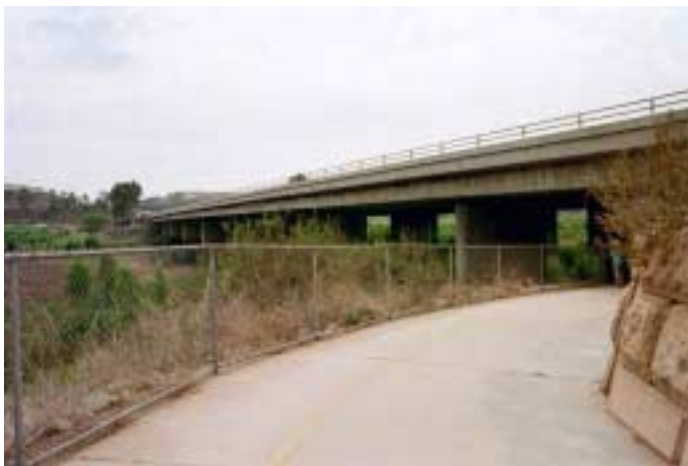
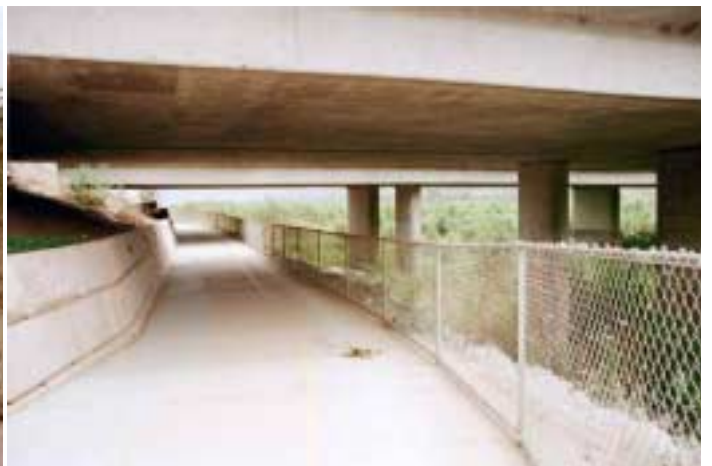
Photo L-2. Lake Hodges—San Pasqual Valley.

I-15 bridge over Lake Hodges/San Dieguito River, looking south from north side.

I-15 bridge over Lake Hodges/San Dieguito River, looking southwest from north side paved trail.

I-15 bridge over Lake Hodges/San Dieguito River, looking east from north side paved trail.

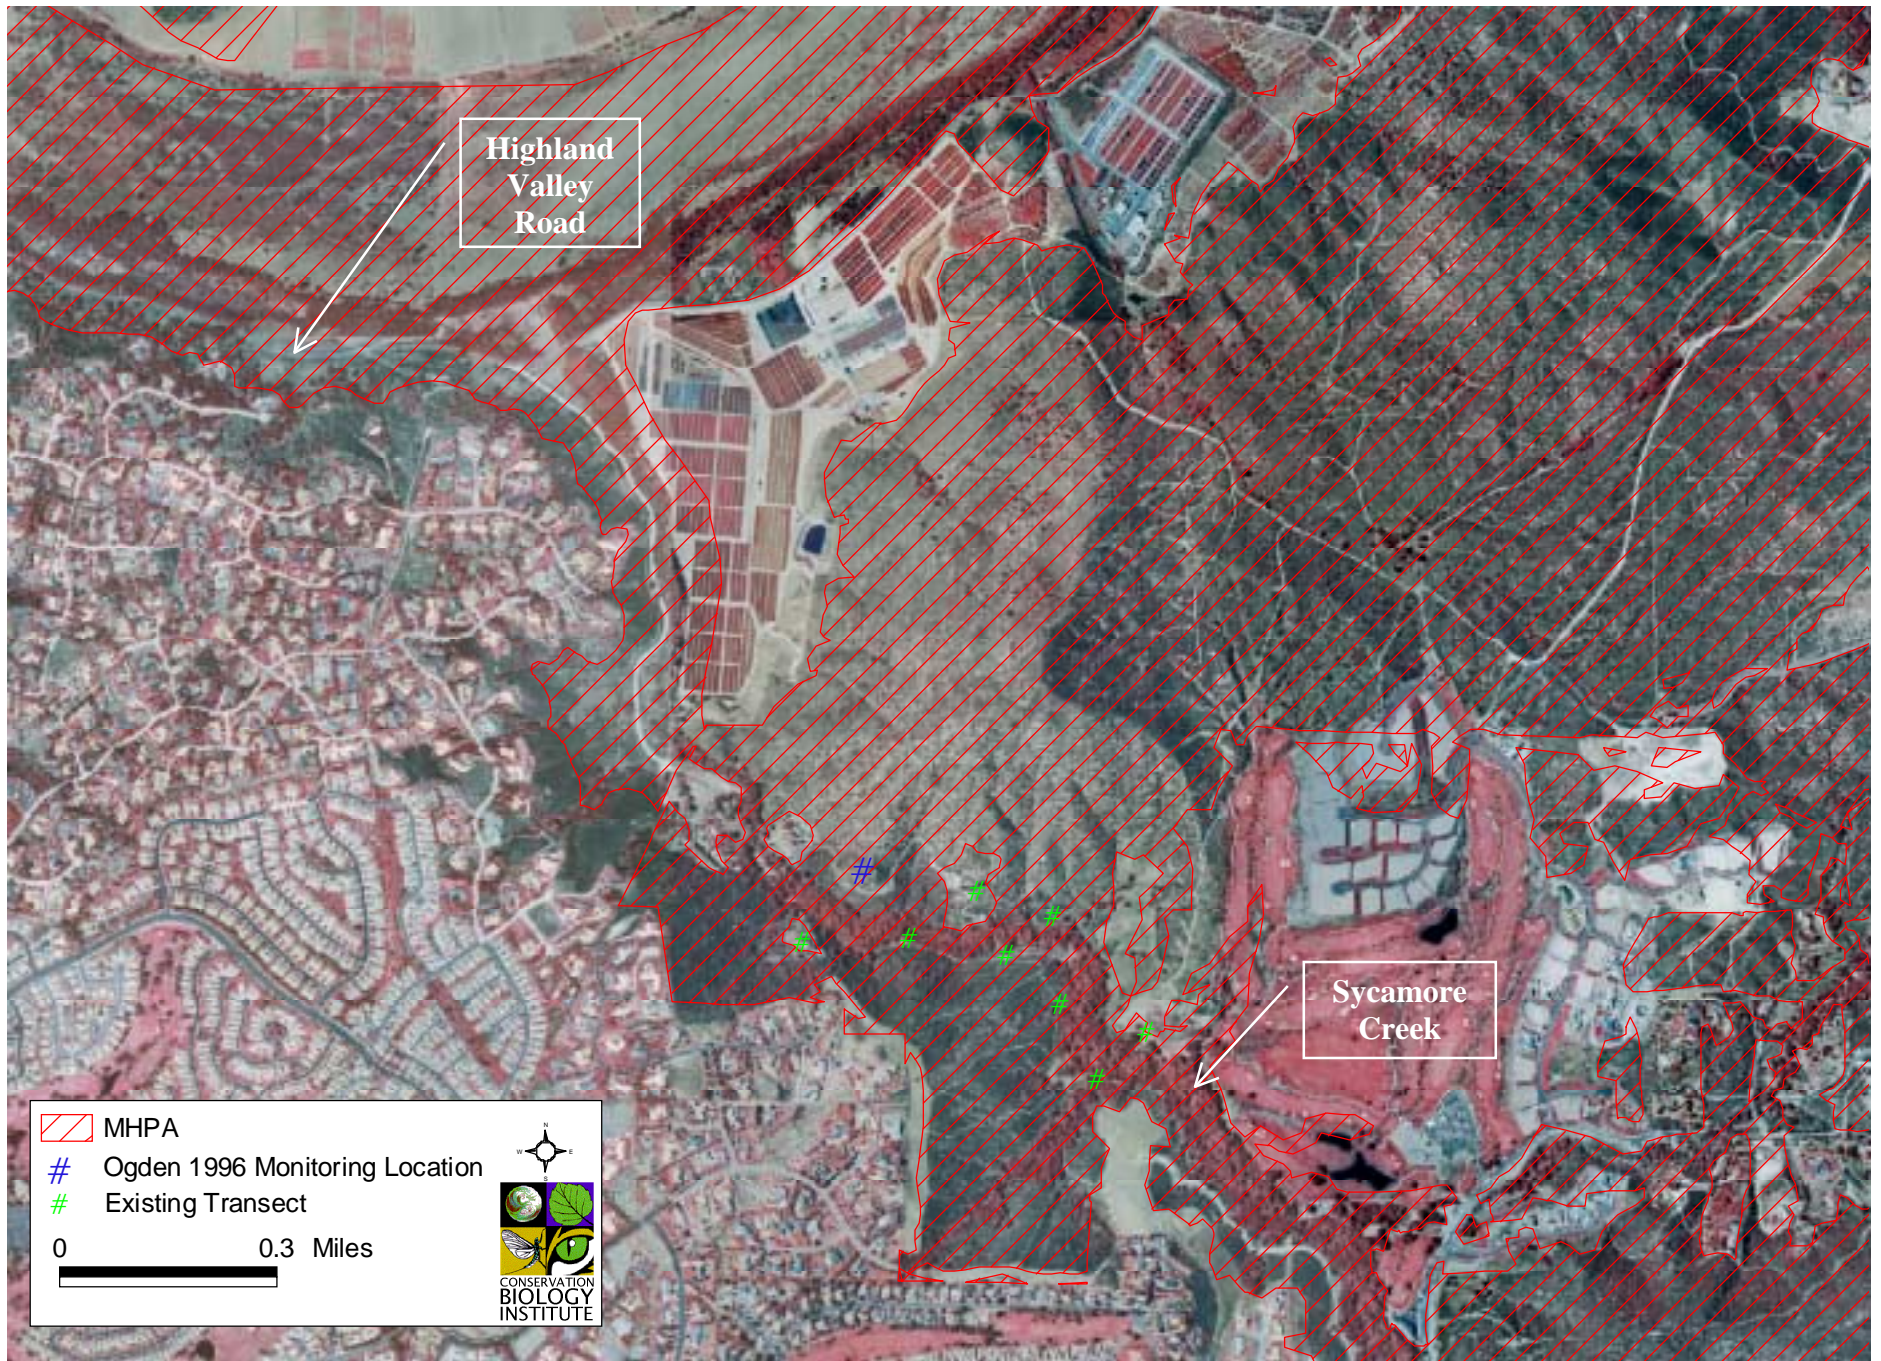
Figure L-3. San Pasqual Valley – North Poway (Sycamore Creek)

CBI (2002b) established and monitored a transect in 2001 and 2002 for this landscape linkage between the Blue Sky Reserve and San Pasqual Valley along Sycamore Creek, and the SDTT has monitored this location quarterly since spring 1999 (Figure L-3). CBI recommends this location for continued monitoring.

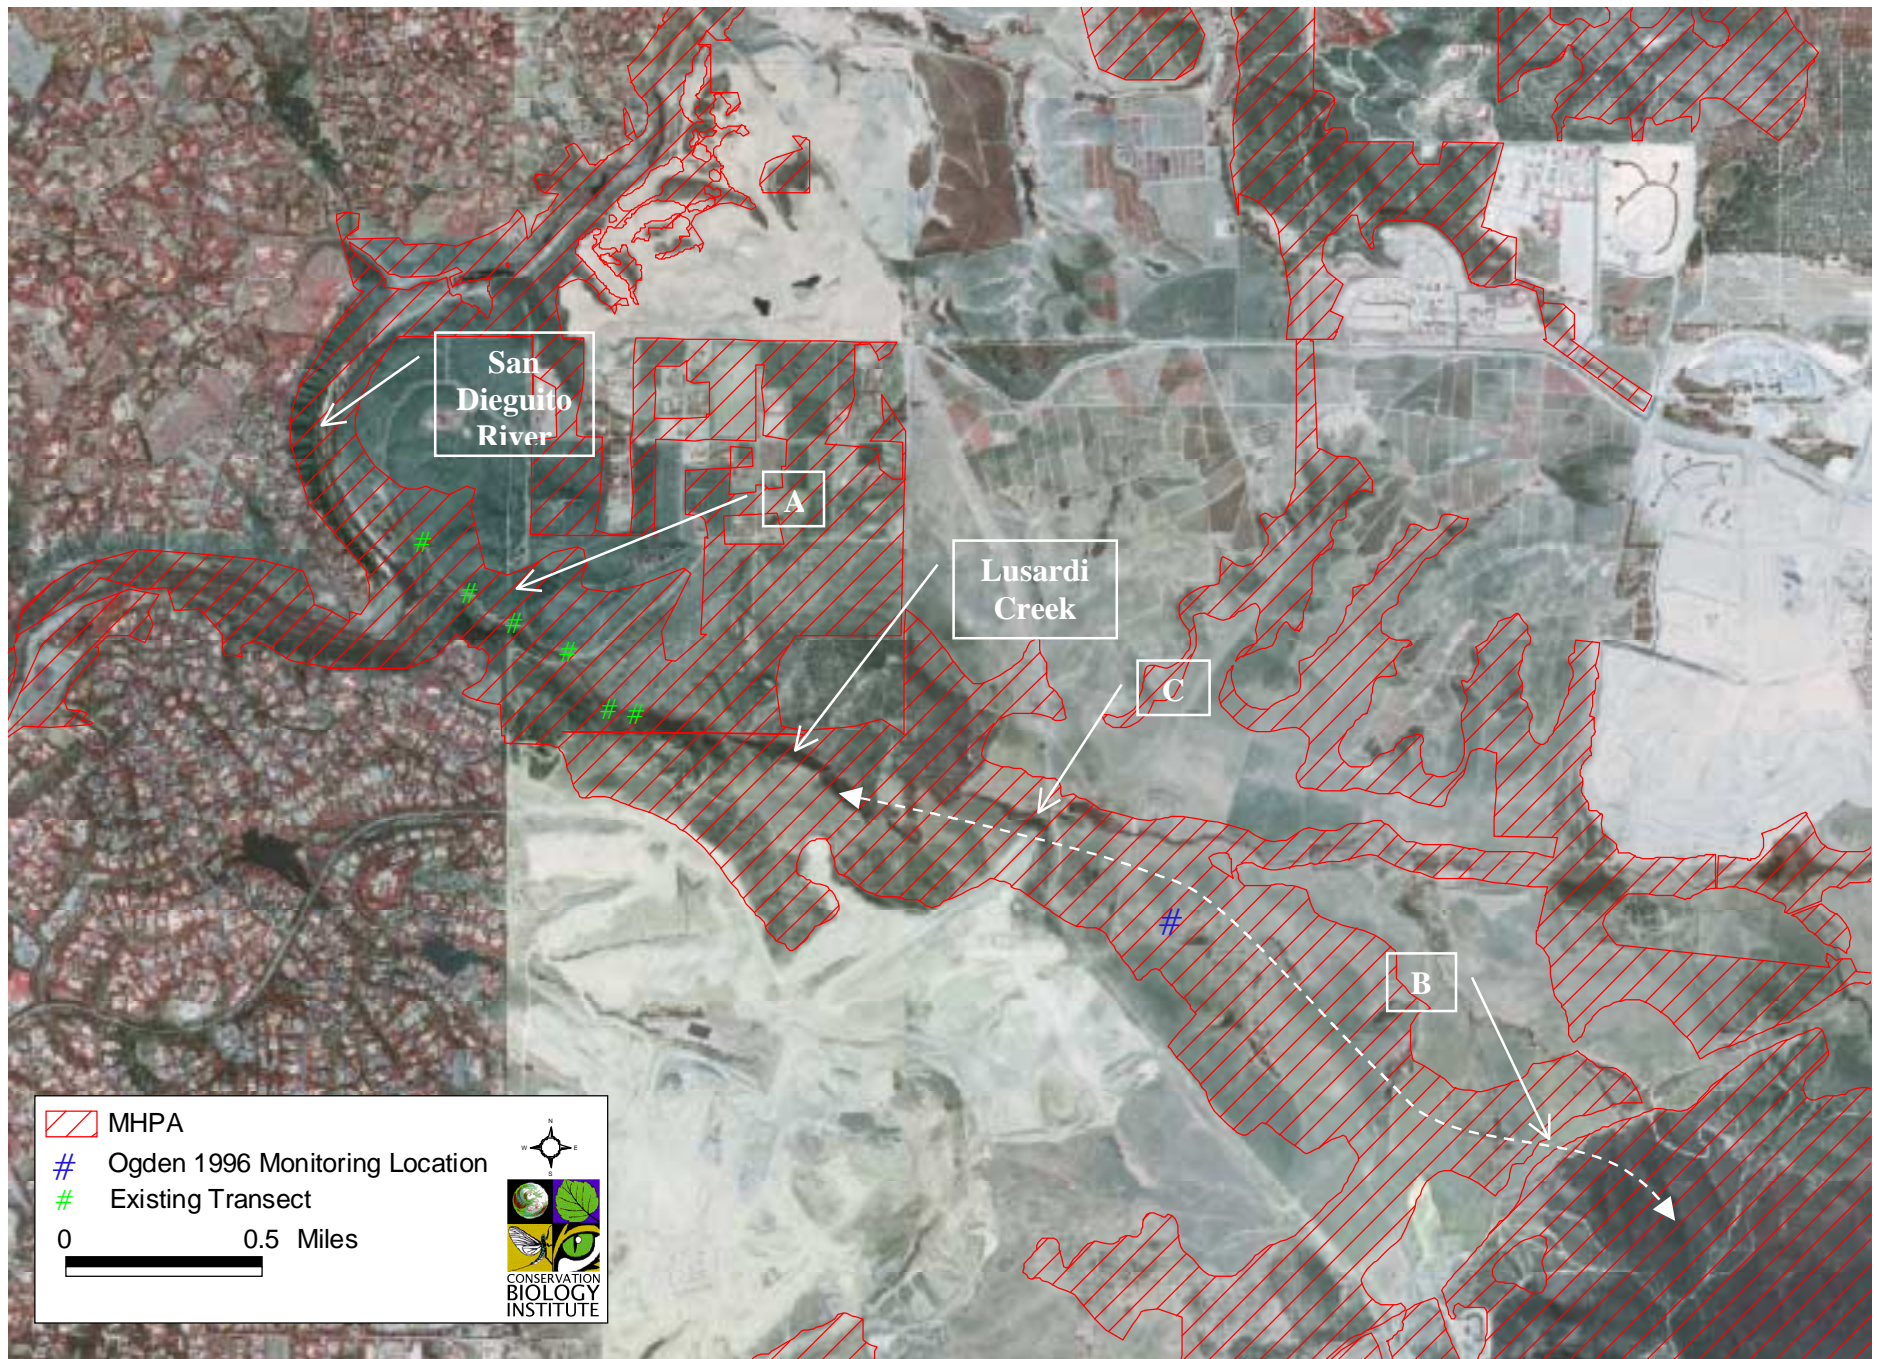
Figure L-4. Lusardi Creek. **A** – west end of Lusardi Creek at San Dieguito River, **B** – at future Carmel Valley Road, and **C** – future Camino Ruiz.

CBI and the SDTT established a transect location at the west end of the canyon, near the mouth of Lusardi Creek at the San Dieguito River (Figure L-4, Location A), and the SDTT monitored this location, from the mouth into the canyon, quarterly in 2002. This transect starts at the mouth of the La Jolla Valley and extends along and adjacent to Lusardi Creek, upstream to a narrowing of the canyon. CBI recommends this location for continued monitoring.

Additional Locations. In addition, CBI recommends placement of monitoring transects at the connection of the eastern Lusardi Creek open space to Black Mountain open space at the future undercrossing of Carmel Valley Road (Location B) and the future undercrossing of Camino Ruiz (Location C, Figure L-4). These sites should be reviewed once construction activities have been completed.

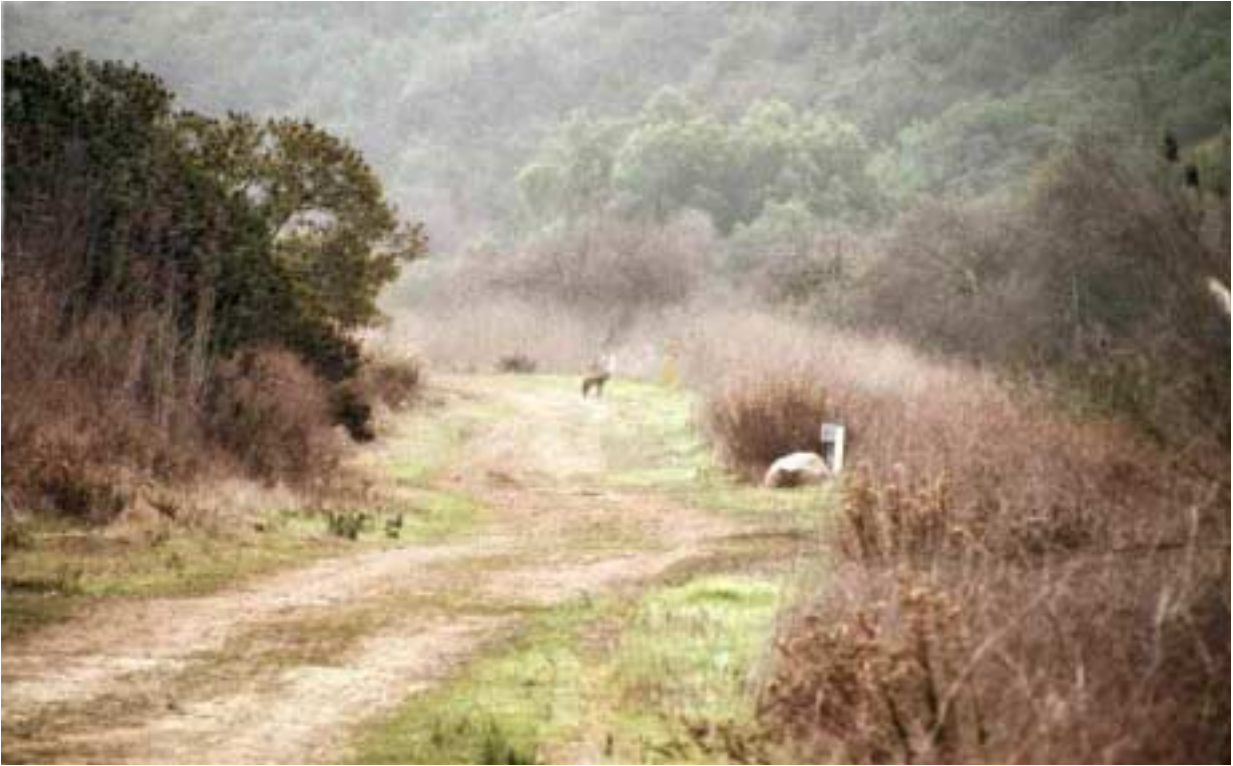
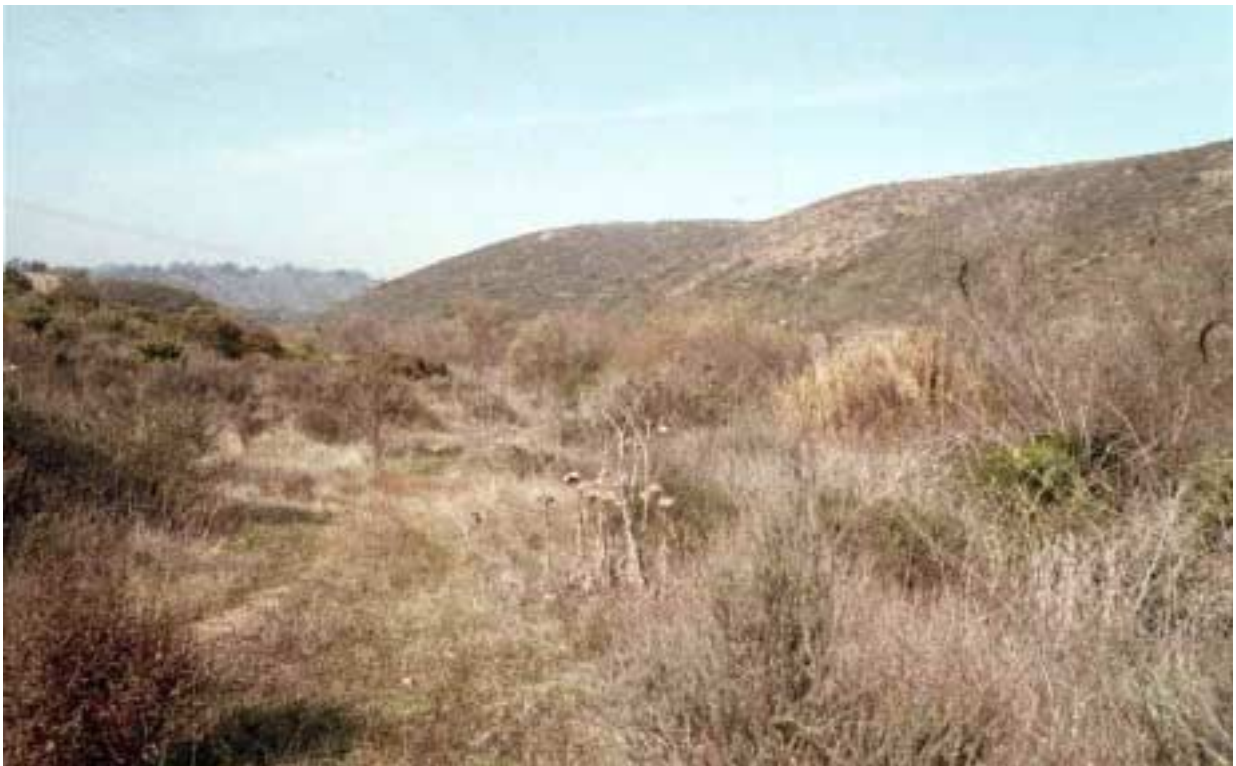
Photo L-4. Lusardi Creek, Location A– west end near confluence with San Dieguito River.

Dirt road at lower end of La Jolla Canyon (Lusardi Creek) looking southeast.

Looking west from south wall of La Jolla Canyon towards San Dieguito River valley.

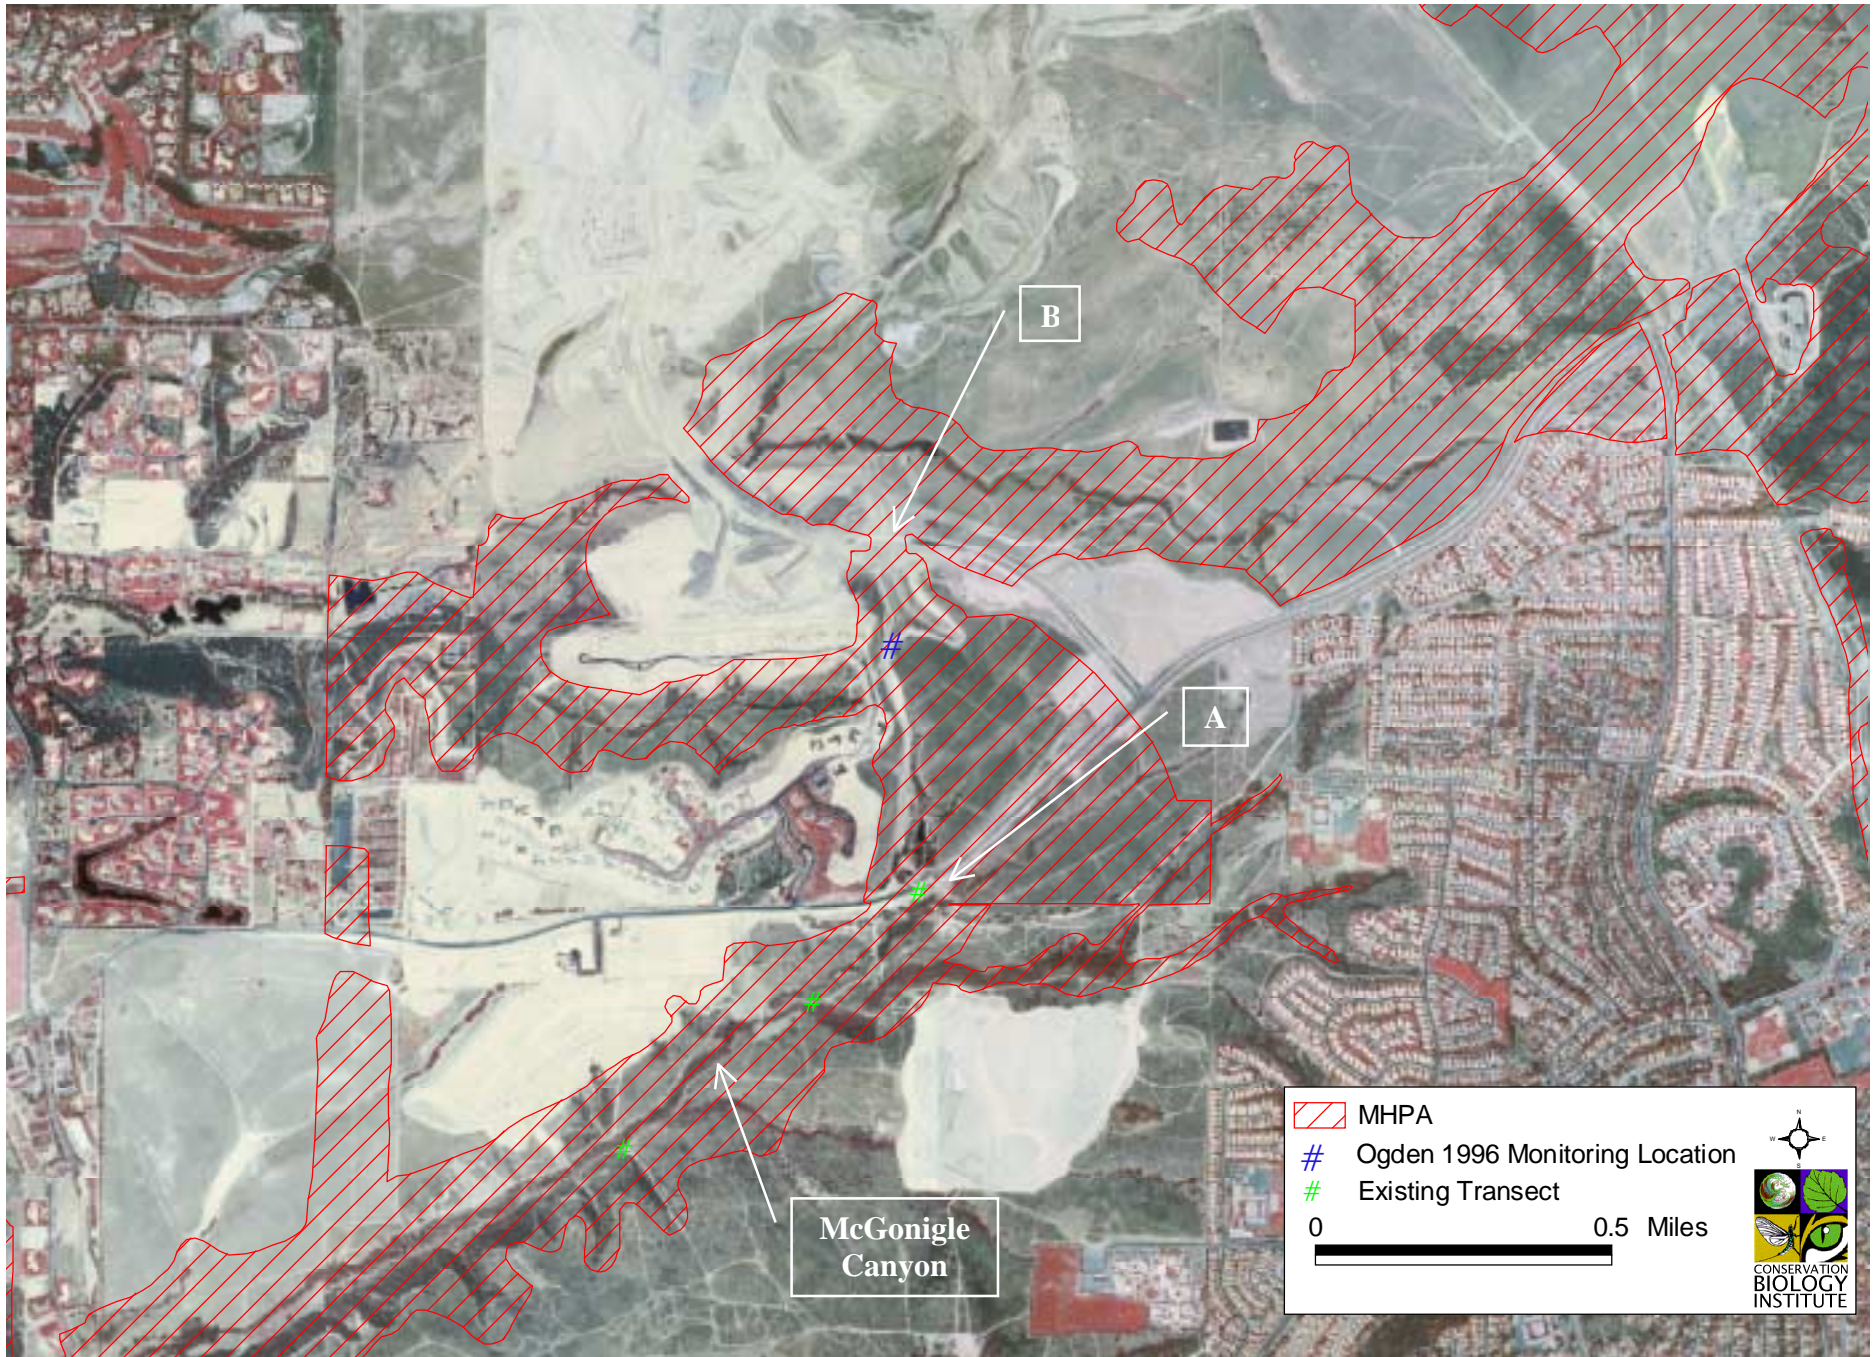
Figure L-6. McGonigle Canyon. A – at future Black Mountain Road bridge and B – at future Camino Ruiz bridge.

Additional Location. CBI also recommends reconnaissance of a possible additional monitoring location at the Camino Ruiz crossing of the north-south tributary (Figure L-6, Location B), once construction has been completed. This open space connection links McGonigle Canyon to the Lusardi Creek open space.

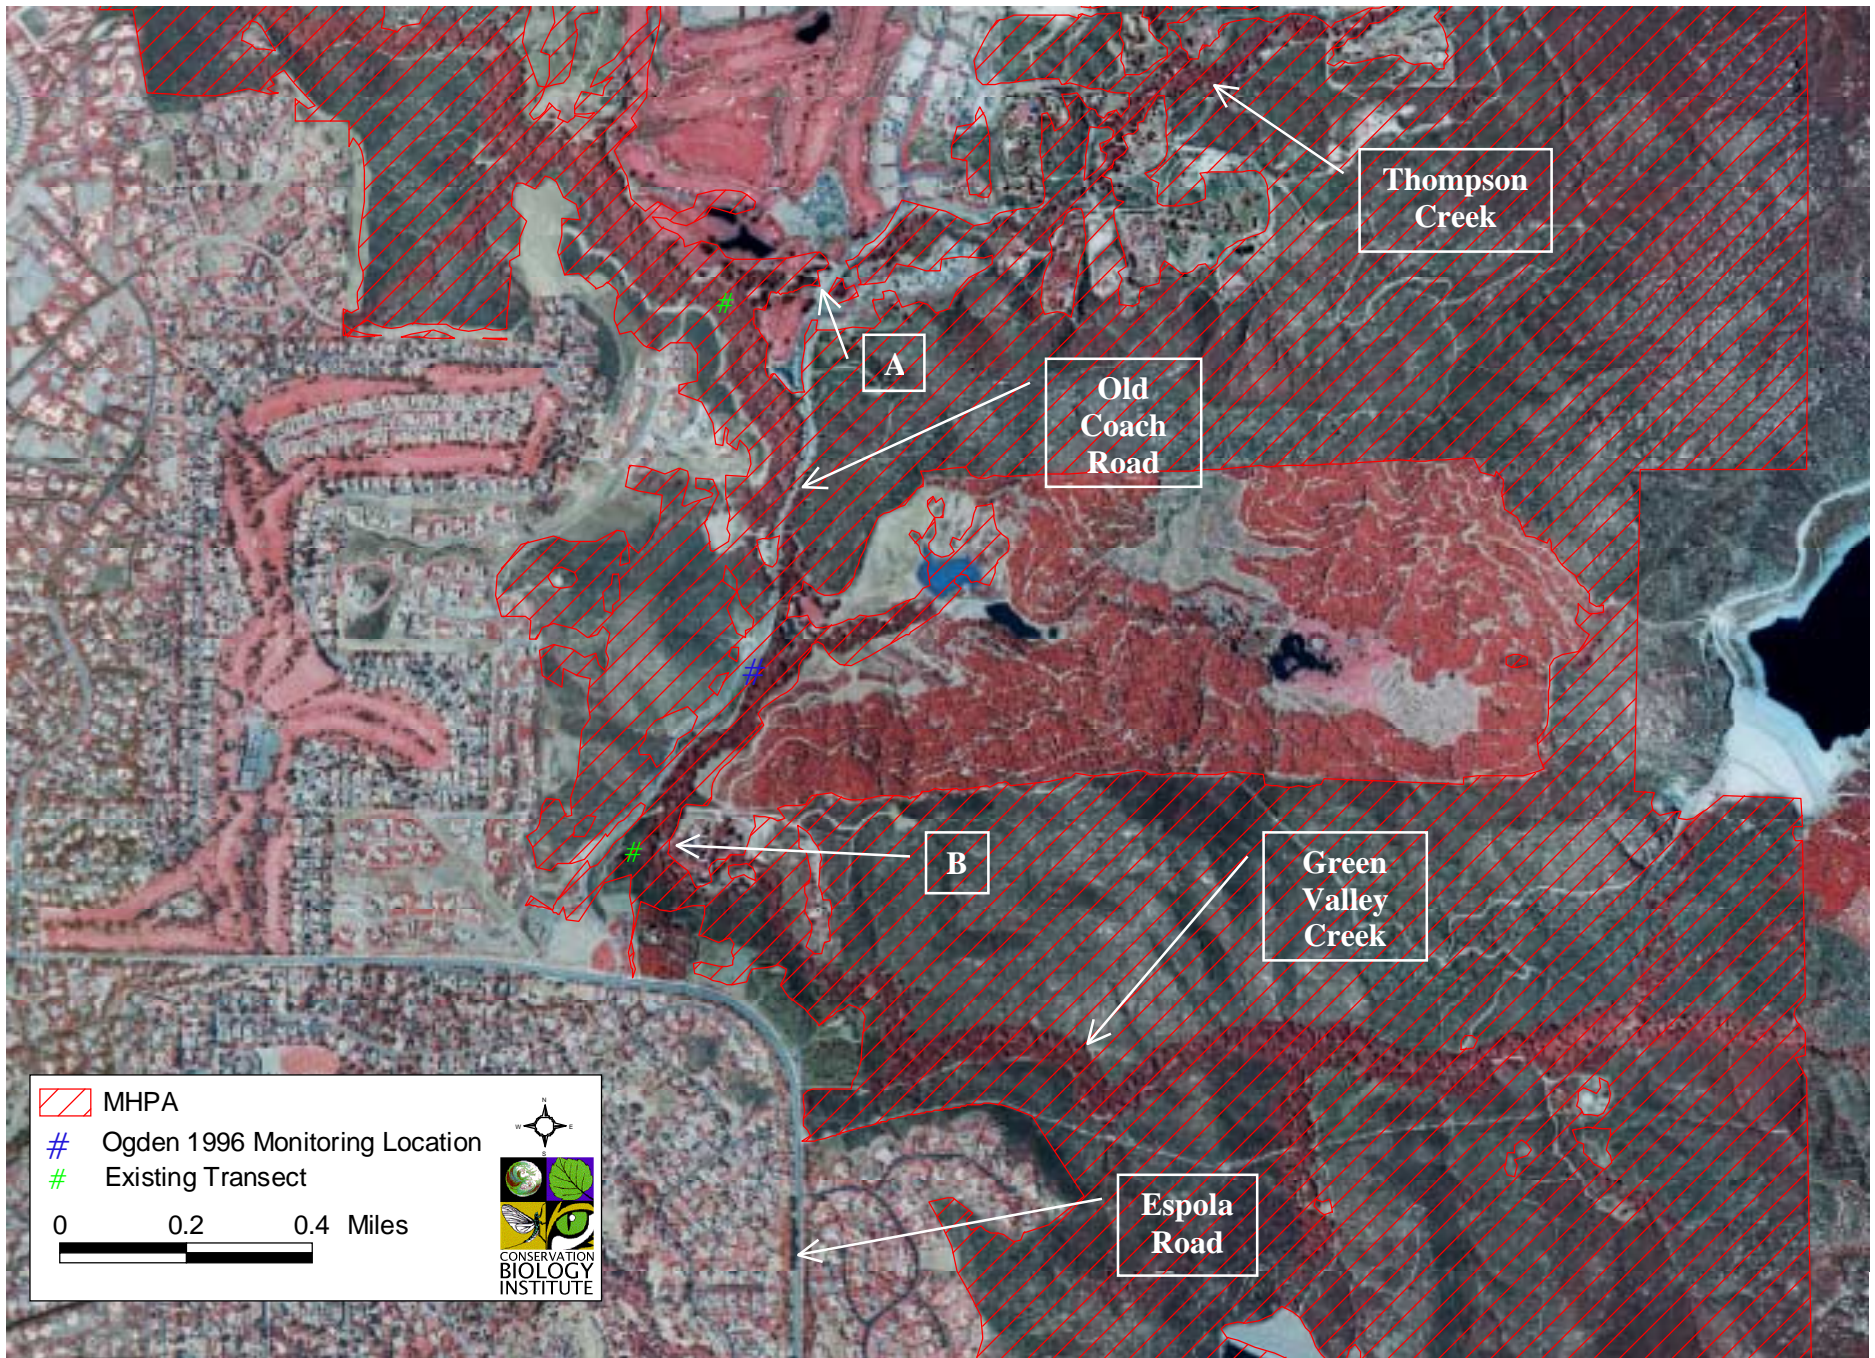
Figure L-7. Old Coach Road – Blue Sky Reserve. **A** – confluence of Green Valley and Thompson Creeks and **B** – Green Valley Creek at Old Coach Road.

CBI (2002b) established and monitored transects in 2001 and 2002 at the confluence of Green Valley Creek and Thompson Creek (Figure L-7, Location A) and along Green Valley Creek at the Old Coach Road bridge (i.e., the Butcher Property, Figure L-7, Location B). CBI recommends these two sites for continued monitoring.

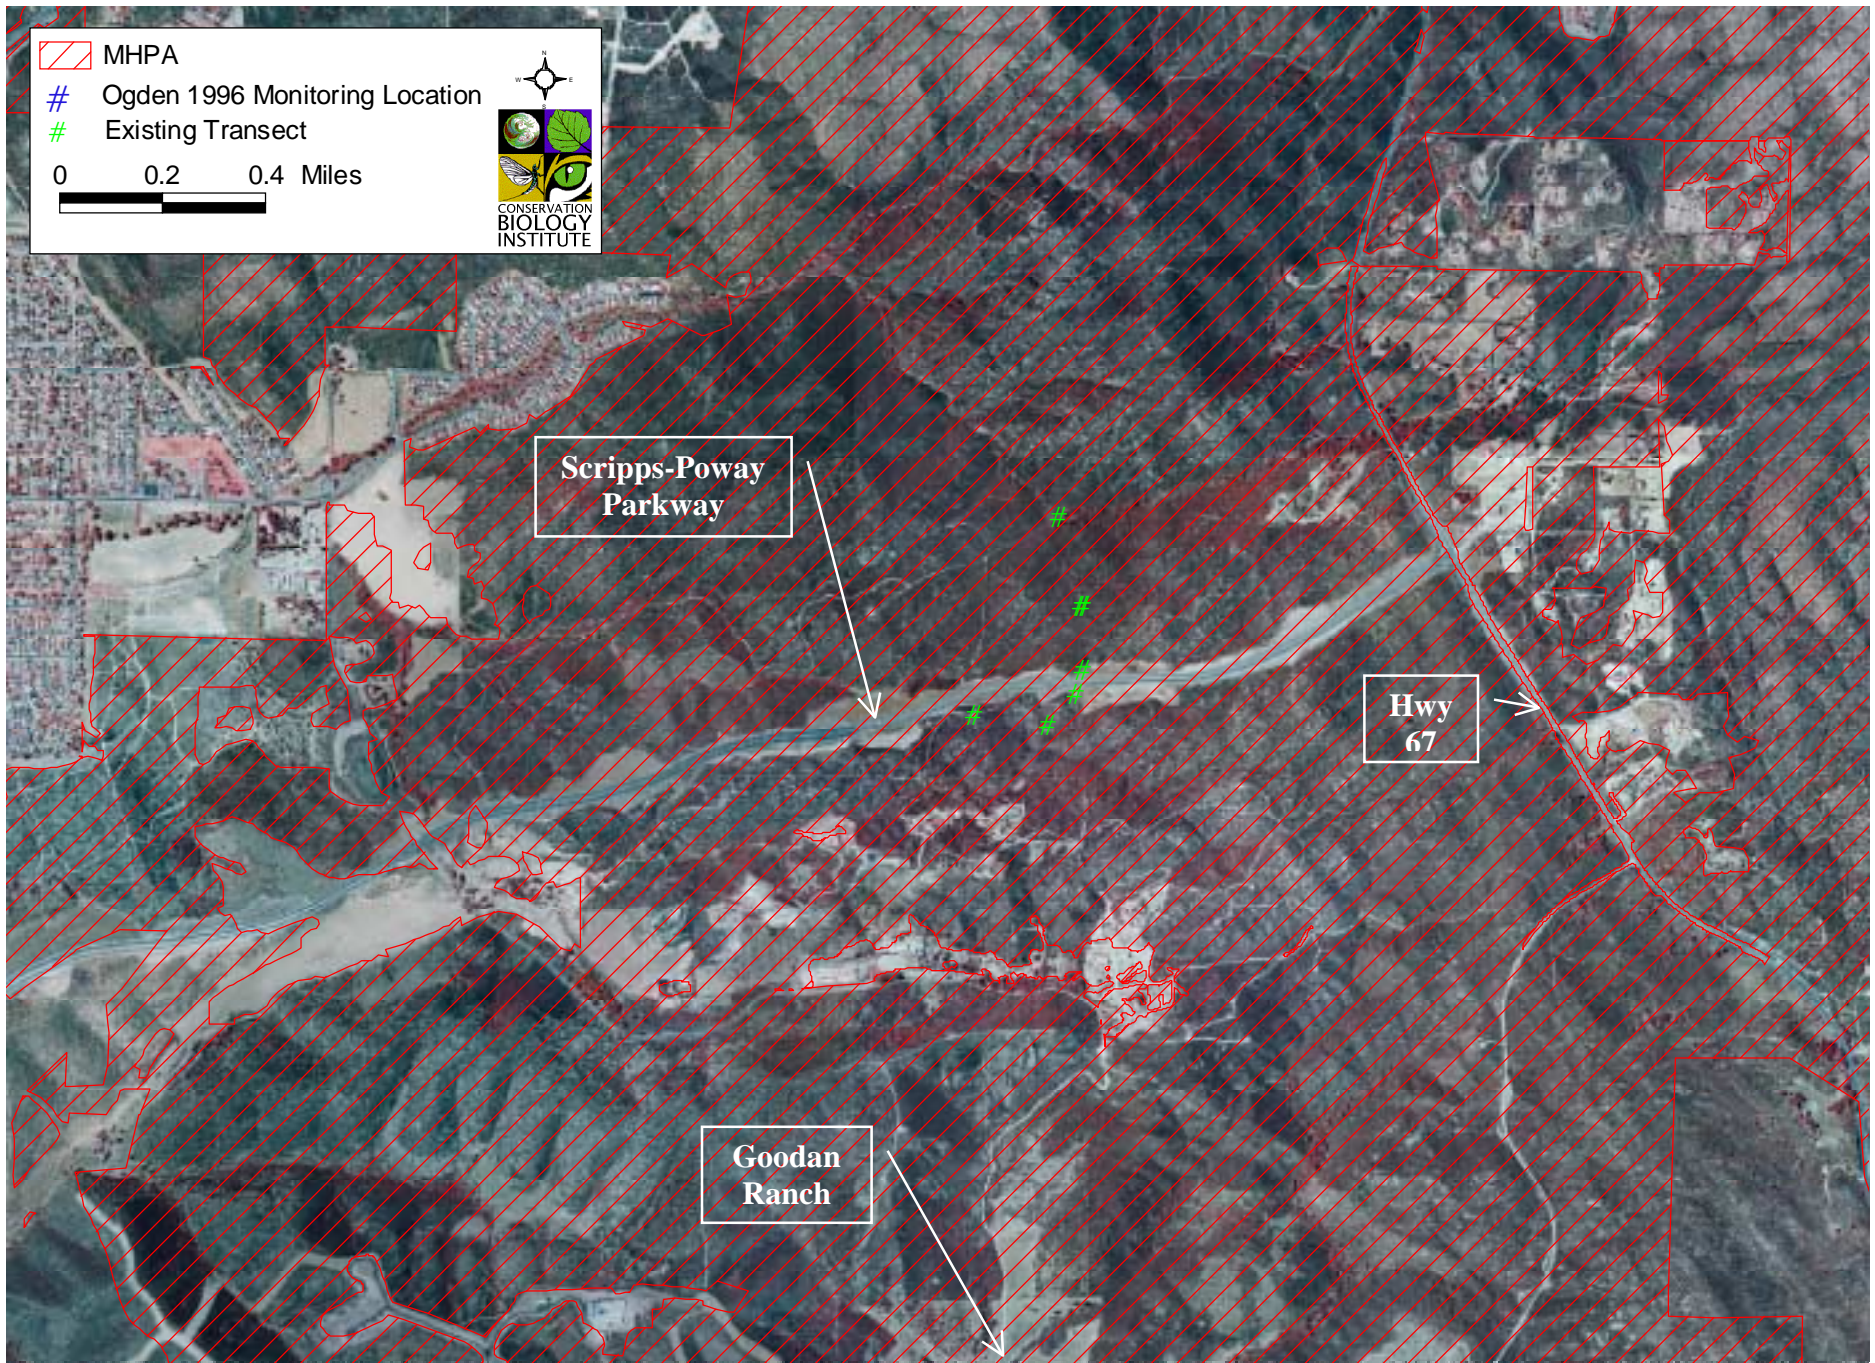
L-8. Central Poway at Scripps-Poway Parkway undercrossing.

CBI (2002b) established and monitored a transect for the Scripps-Poway Parkway wildlife crossing in 2001 (Figure L-8). The SDTT also monitored this site quarterly for CBI in 2002. (The SDTT has monitored this site quarterly since the spring quarter of 1999). The wildlife crossing allows wildlife movement between currently undeveloped areas north and south of Scripps-Poway Parkway. CBI recommends this location for continued monitoring.

Alternative Location. CBI does not recommend an alternative location at this time. An alternative location should be reevaluated if new residential growth south of Scripps-Poway Parkway begins to impede movement between Scripps-Poway Parkway and the Sycamore Canyon/Goodan Ranch open space preserves.
