REVIEW OF REGIONAL HABITAT LINKAGE MONITORING LOCATIONS

Multiple Species Conservation Program

January 2003

California Department of Fish and Game
NCCP Local Assistance Grant #P0050009

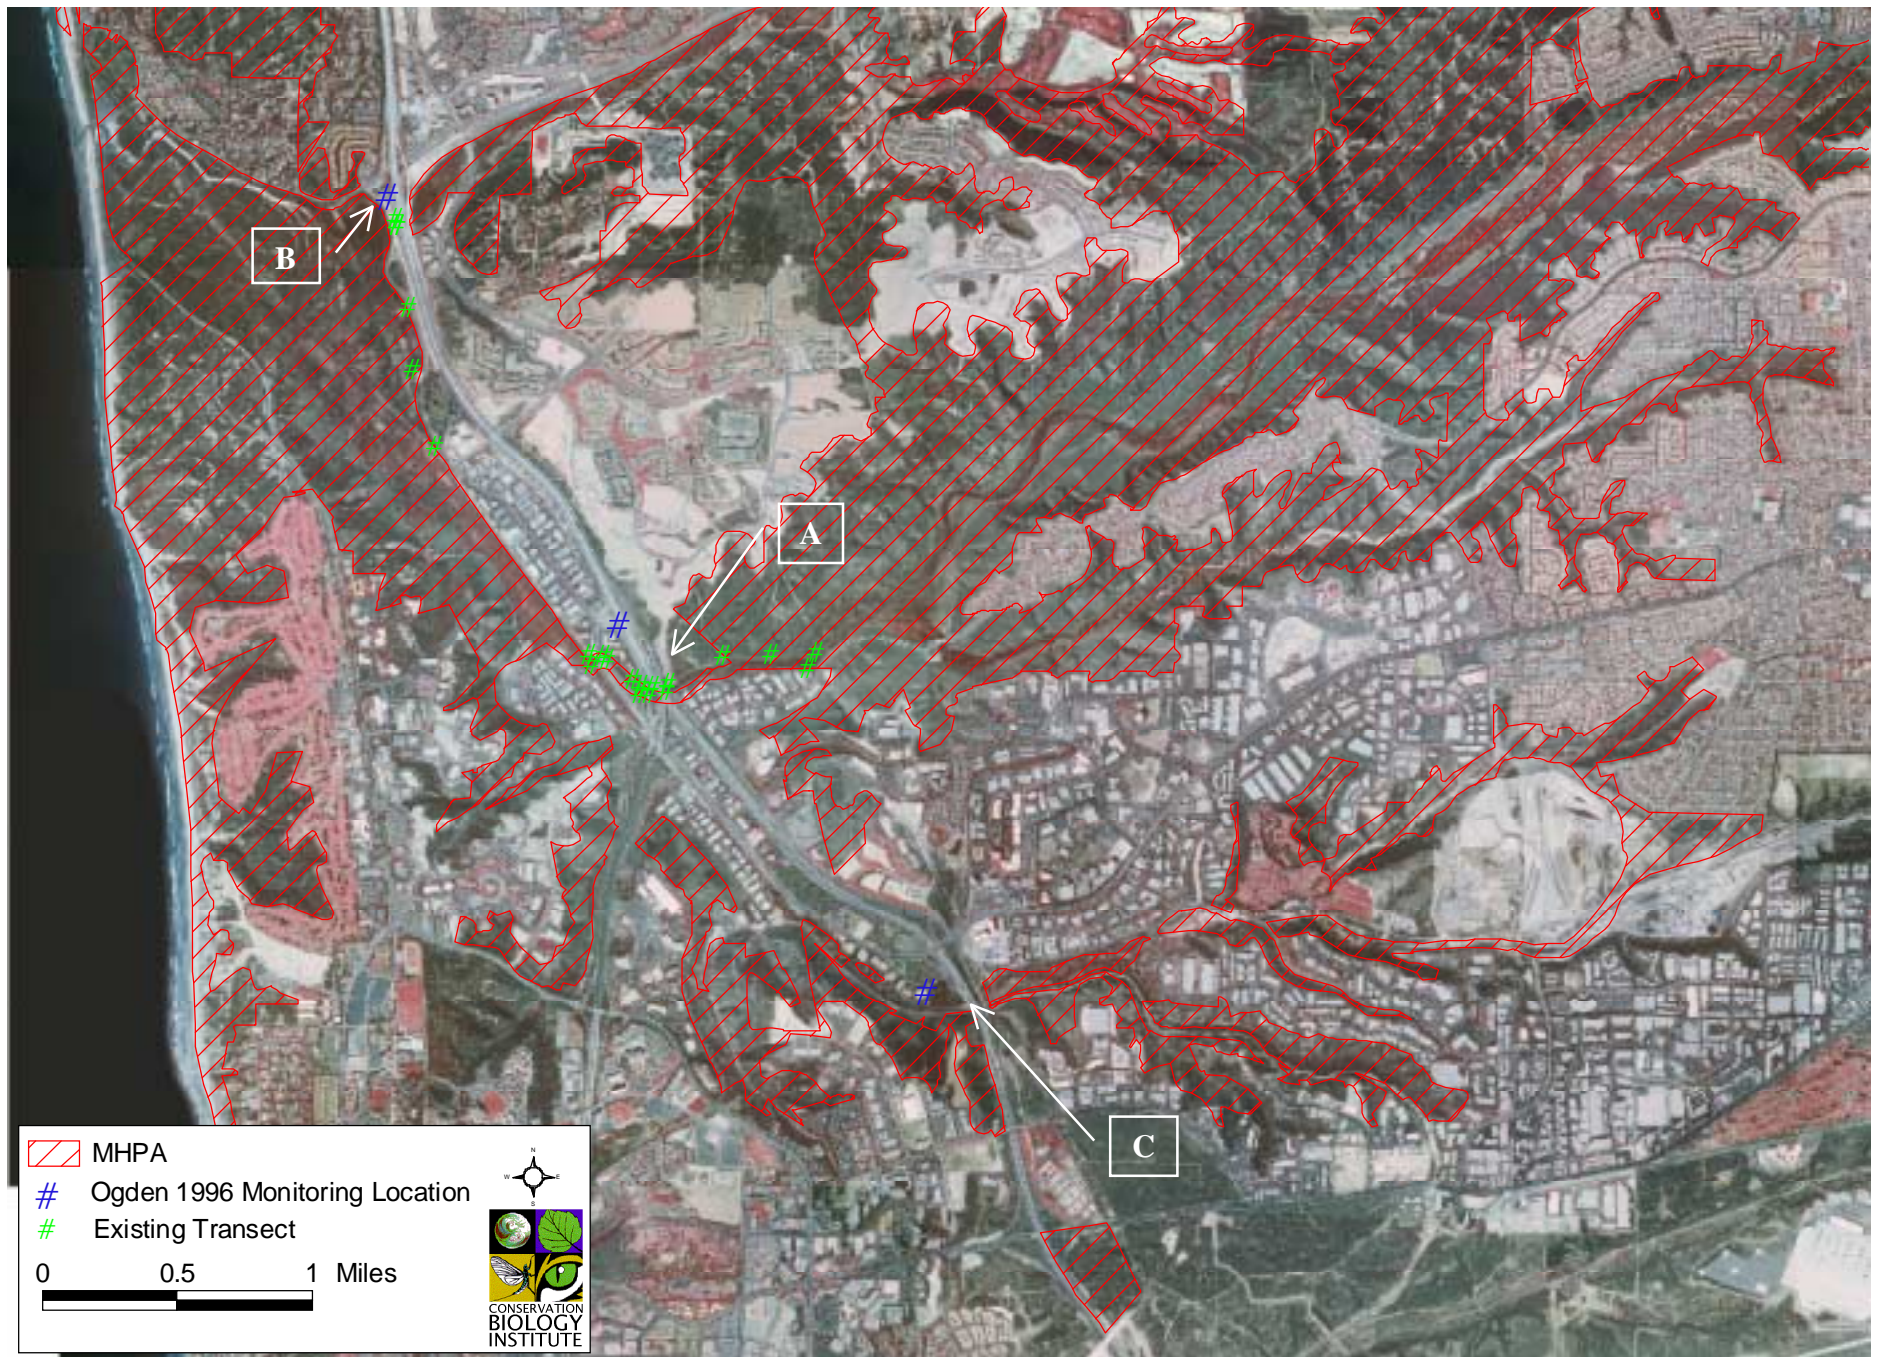
Figure L-9. Torrey Pines State Reserve – Los Peñasquitos Canyon. **A** – at I-5/805 merge, **B** – at I-5 overpass of Carmel Creek, and **C** – Carroll Canyon.

Alternative Location. The MSCP Biological Monitoring Plan (Ogden 1996) recommended a corridor monitoring location at the connection into Carroll Canyon (Figure L-9, Location C). This area represents a steppingstone corridor of coastal sage scrub connecting the Los Peñasquitos Canyon Preserve with MCAS Miramar, presumably intended primarily for California gnatcatcher dispersal. CBI does not recommend this location for monitoring movement of large mammals.

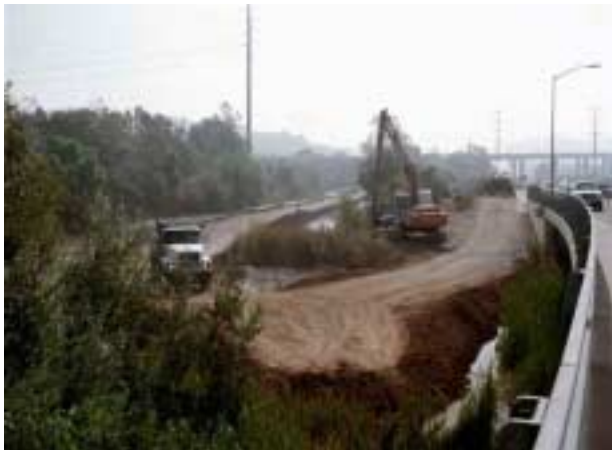
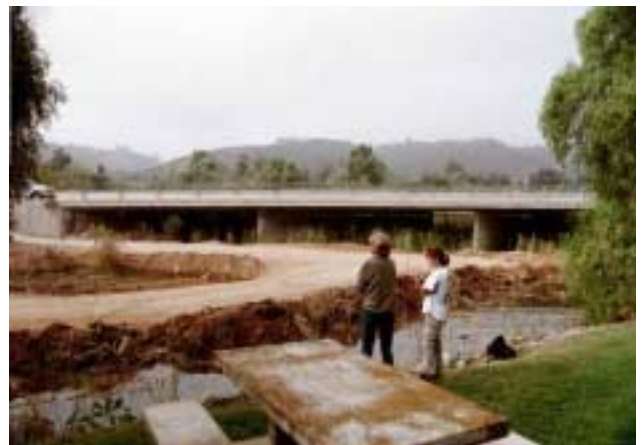
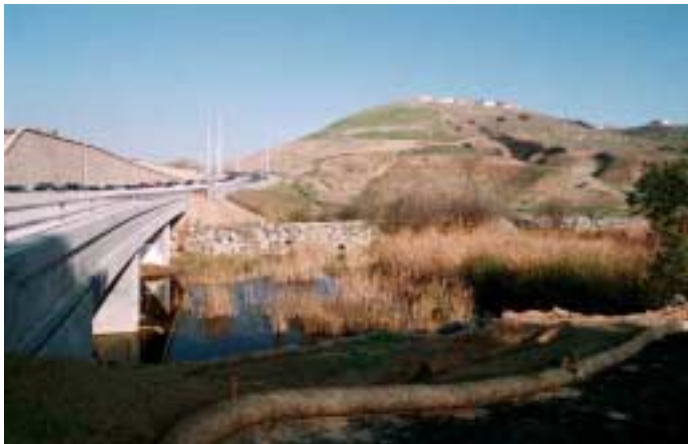
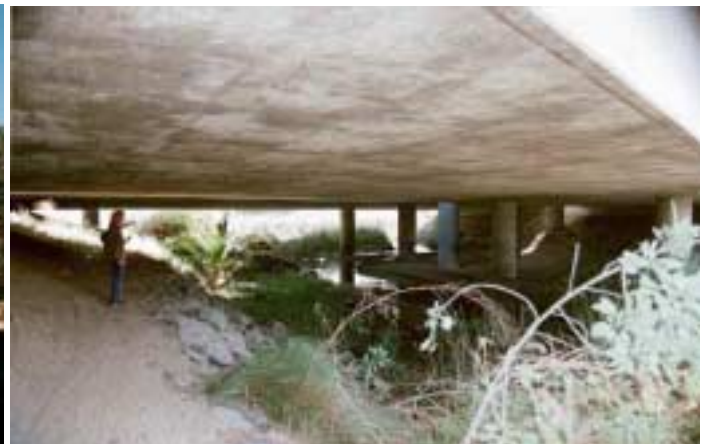
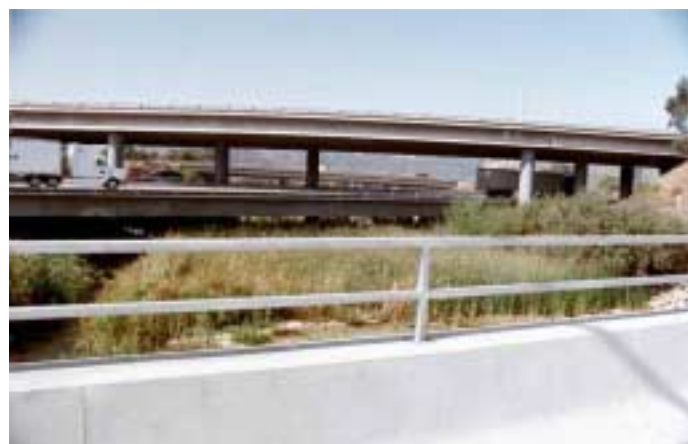
Photo L-9. Torrey Pines State Reserve—Los Peñasquitos Canyon—Miramar, Location A—I-5/805 merge bridges.

Dredging project in L-9 linkage, looking south from Sorrento Valley Rd bridge.

Sorrento Valley Rd bridge over Peñasquitos Creek looking west.

Vista Sorrento Pkwy bridge over Peñasquitos Creek looking north.

Vista Sorrento Pkwy bridge over Peñasquitos Creek looking east.

I-5/805 merge bridges, looking west from Vista Sorrento Pkwy bridge.

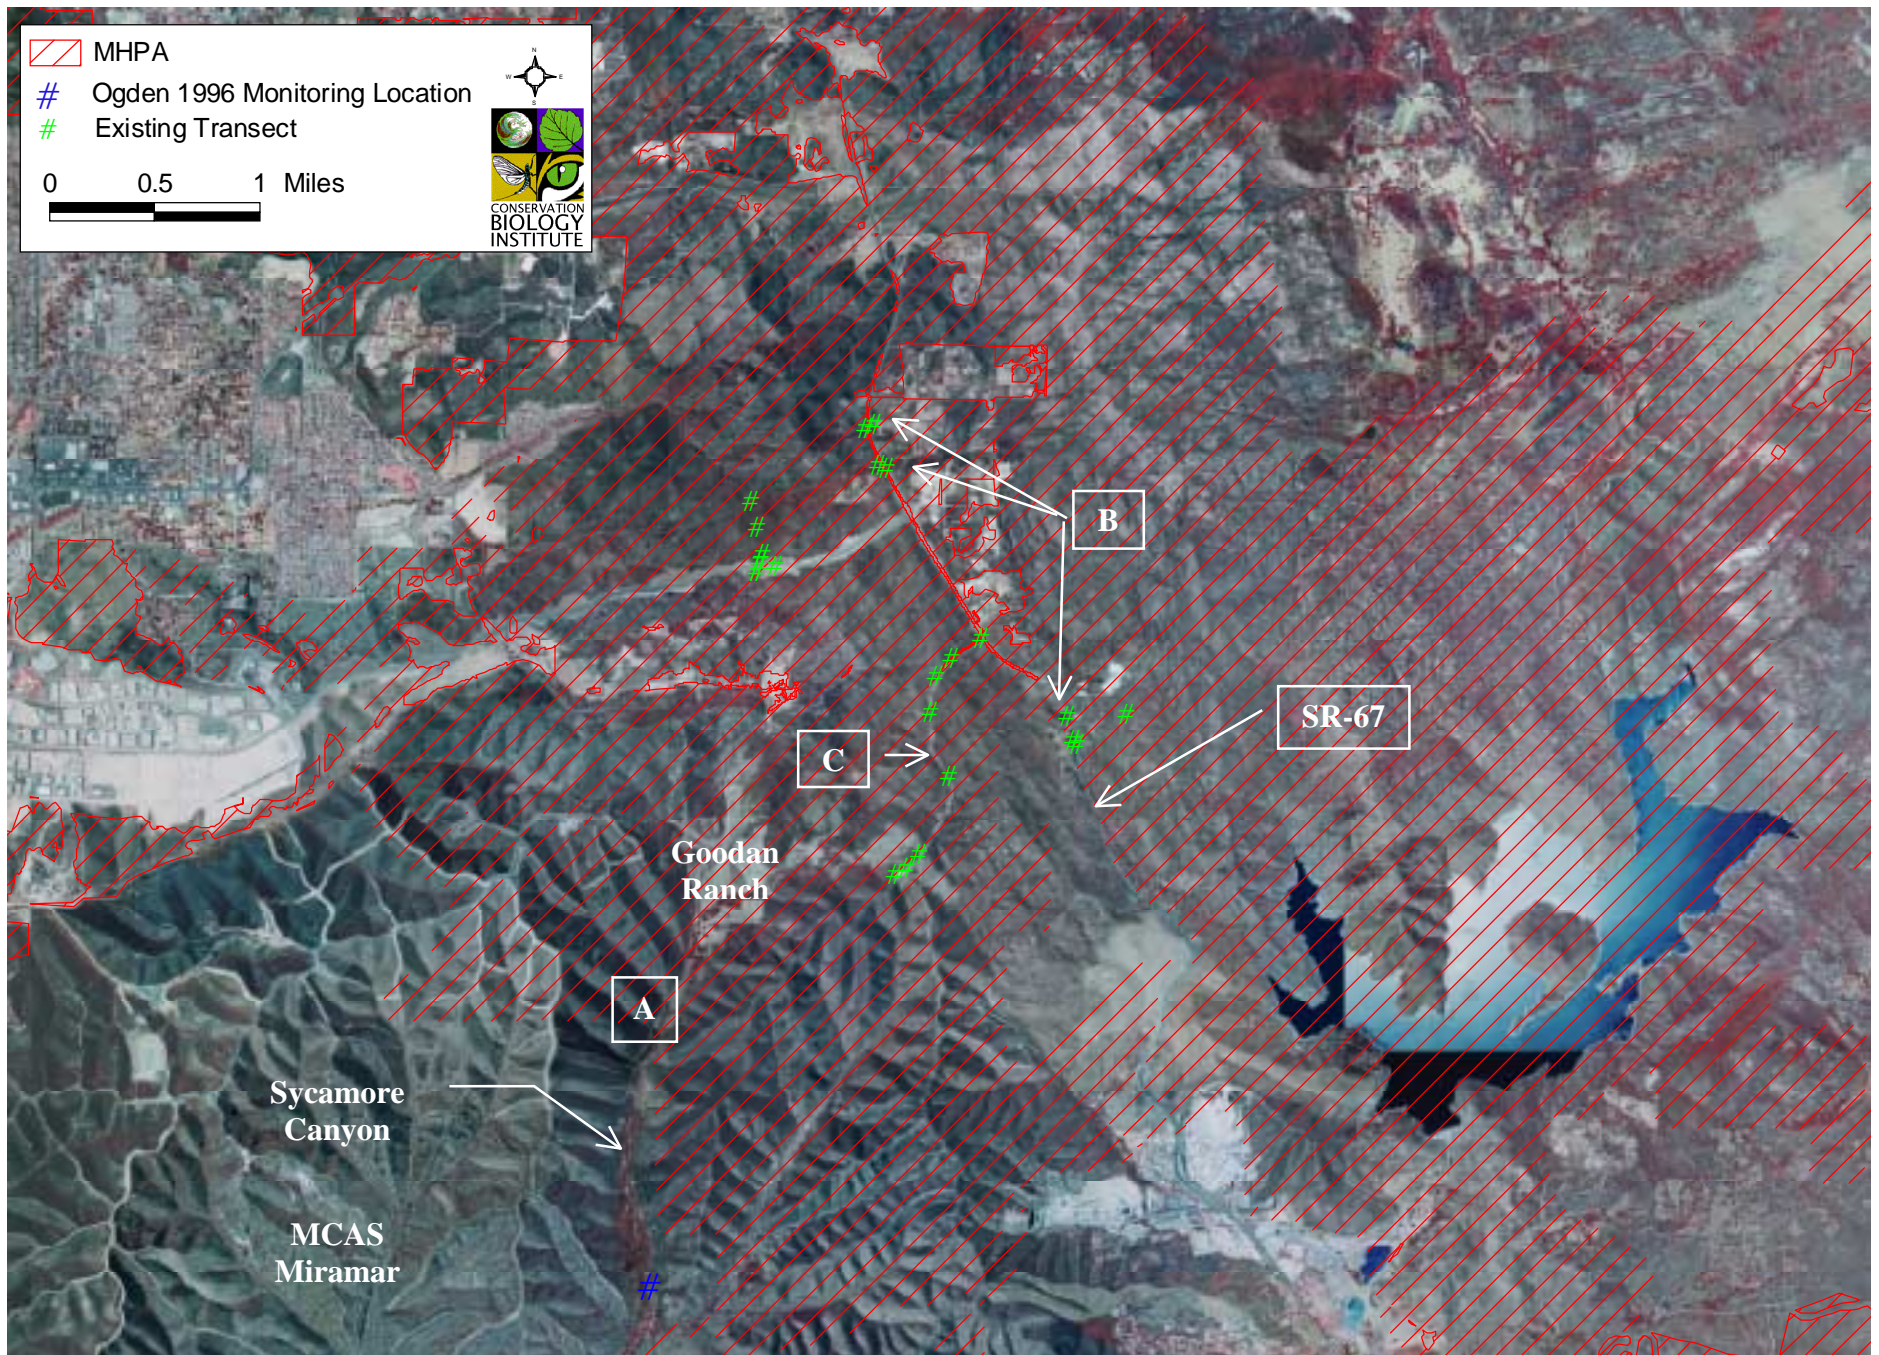
Figure L-11. South Poway - Santee (Sycamore and Clark Canyons). **A** – Sycamore Canyon, **B** – culverts under SR-67, and **C** – Sycamore Park Drive.

Alternative Locations. CBI and the SDTT established transects and cameras at culverts under SR-67, north and south of Scripps-Poway Parkway (Figure L-11, Location B). The SDTT monitored these transects quarterly in 2002. The SR-67 culverts south of Scripps-Poway Parkway connect the Sycamore Canyon/Goodan Ranch Open Space Preserves with the San Vicente Highlands open space (formerly known as the Boys and Girls Club property) east of SR-67. These culverts have been used by large mammals (e.g., bobcats) as well as humans. CBI recommends continued monitoring at these culverts as part of regional linkage monitoring.

The SDTT also established and has monitored a transect quarterly along Sycamore Park Drive, off of SR-67 since winter quarter 2000 (Figure L-11, Location C). This transect serves to monitor wildlife use within the Goodan Ranch Open Space Preserve. CBI does not recommend continued monitoring at Sycamore Park Drive as part of regional wildlife corridor monitoring, but does recommend continued monitoring at this location to inform preserve management.

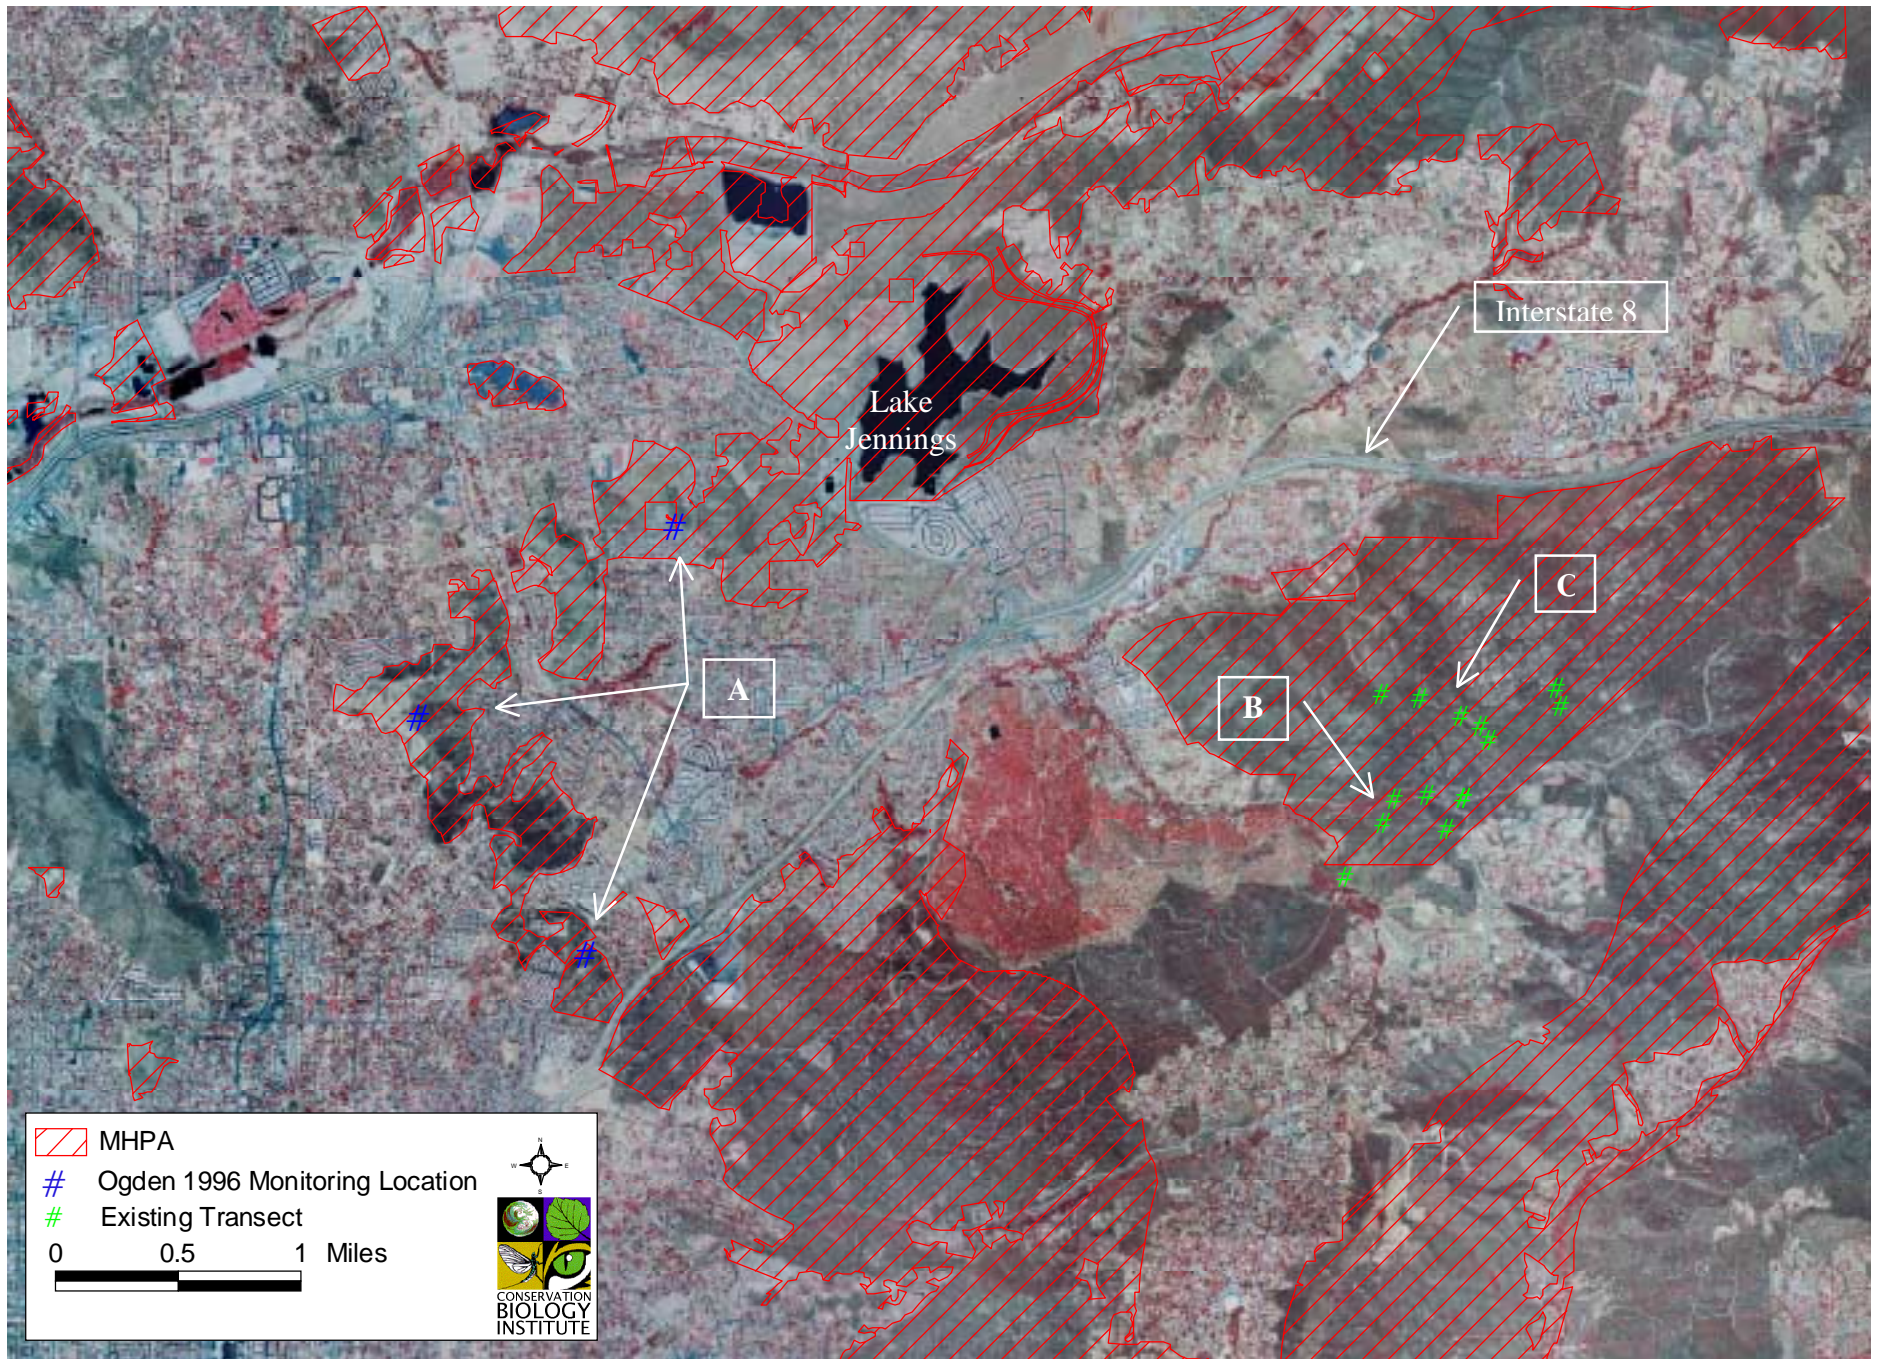
Figure L-12. Lakeside – Crest – El Cajon. **A** – Lakeside Archipelago, and **B**, **C** – SDTT transects at Crestridge Ecological Reserve.

This area is an archipelago of coastal sage scrub habitat fragments that link open space north and south of I-8 (Figure L-12, Location A). This area of fragmented open space, roads, and rural residential development likely supports dispersal of birds and flying invertebrates. Regular movement by large mammals through this area is unlikely. The MSCP Plan hypothesizes that these habitat islands are used by California gnatcatchers to disperse between larger, core habitat areas. The County of San Diego has initiated monitoring of dispersing birds through this area. We do not recommend establishing a corridor monitoring location for large mammals in the archipelago.

Alternative Location. The SDTT established two transects at the Crestridge Ecological Reserve in this area, just south of I-8 (one in spring 1999 and one in spring 2002) and has monitored them quarterly through 2002 (Figure L-12, Locations B and C). Data collected at Crestridge will be valuable to understanding the degree of isolation of this reserve, which is largely surrounded by residential development and roads. Crestridge likely functions more as a core resource area rather than a linkage. CBI recommends continued monitoring at Crestridge to inform habitat management decisions on the reserve, but CBI does not recommend these locations as regional habitat linkage monitoring locations for large mammals.

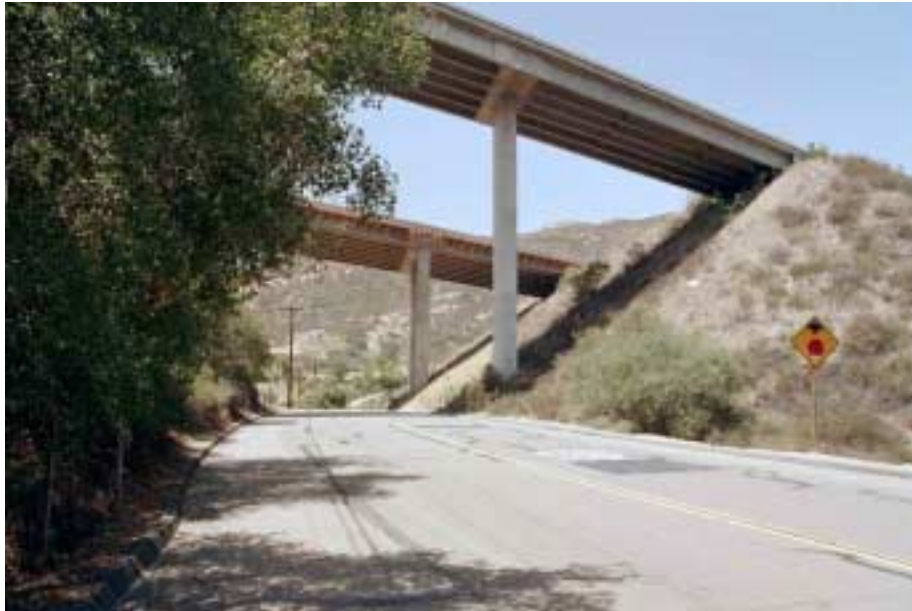
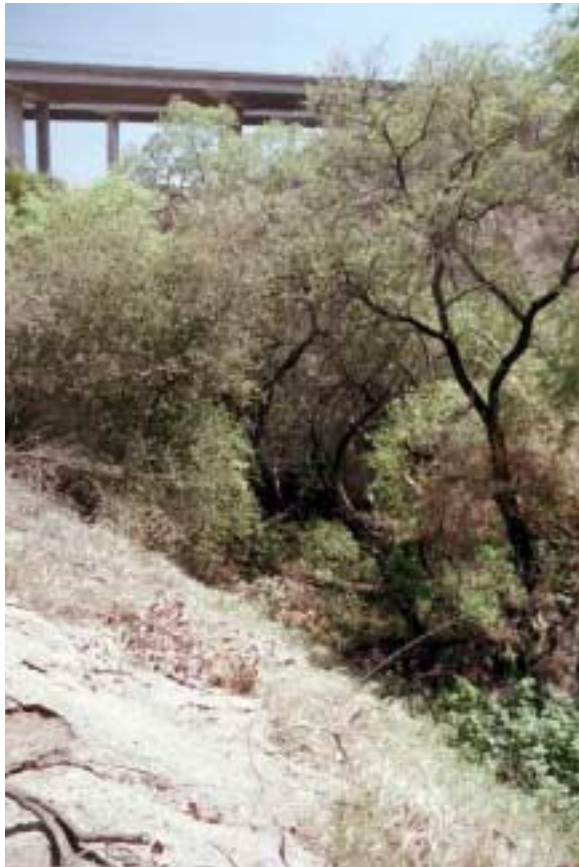
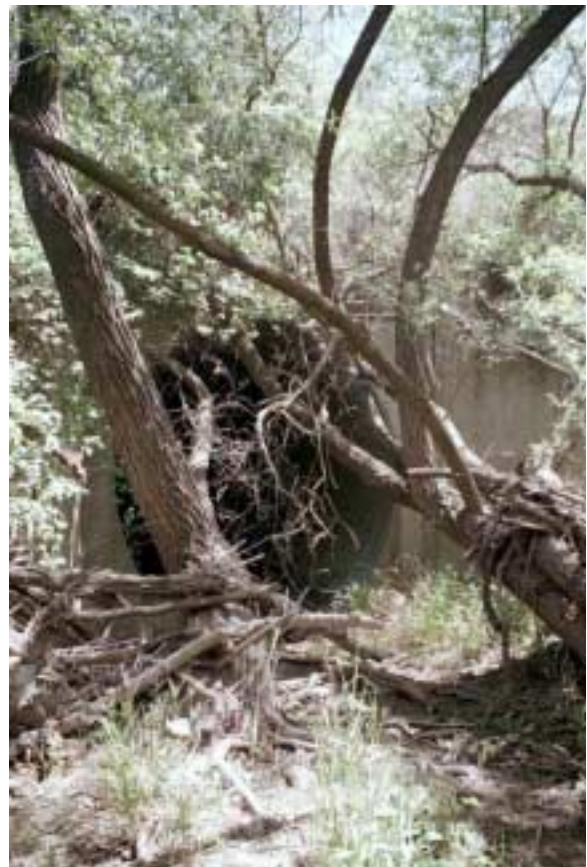
Photo L-13. Harbison Canyon at I-8, Location A—Peutz Valley Road under I-8.

Peutz Valley Road under I-8 overpass, looking north.

Chocolate Creek with I-8 overpass in background.

Chocolate Creek culvert under Peutz Valley Rd, looking north.

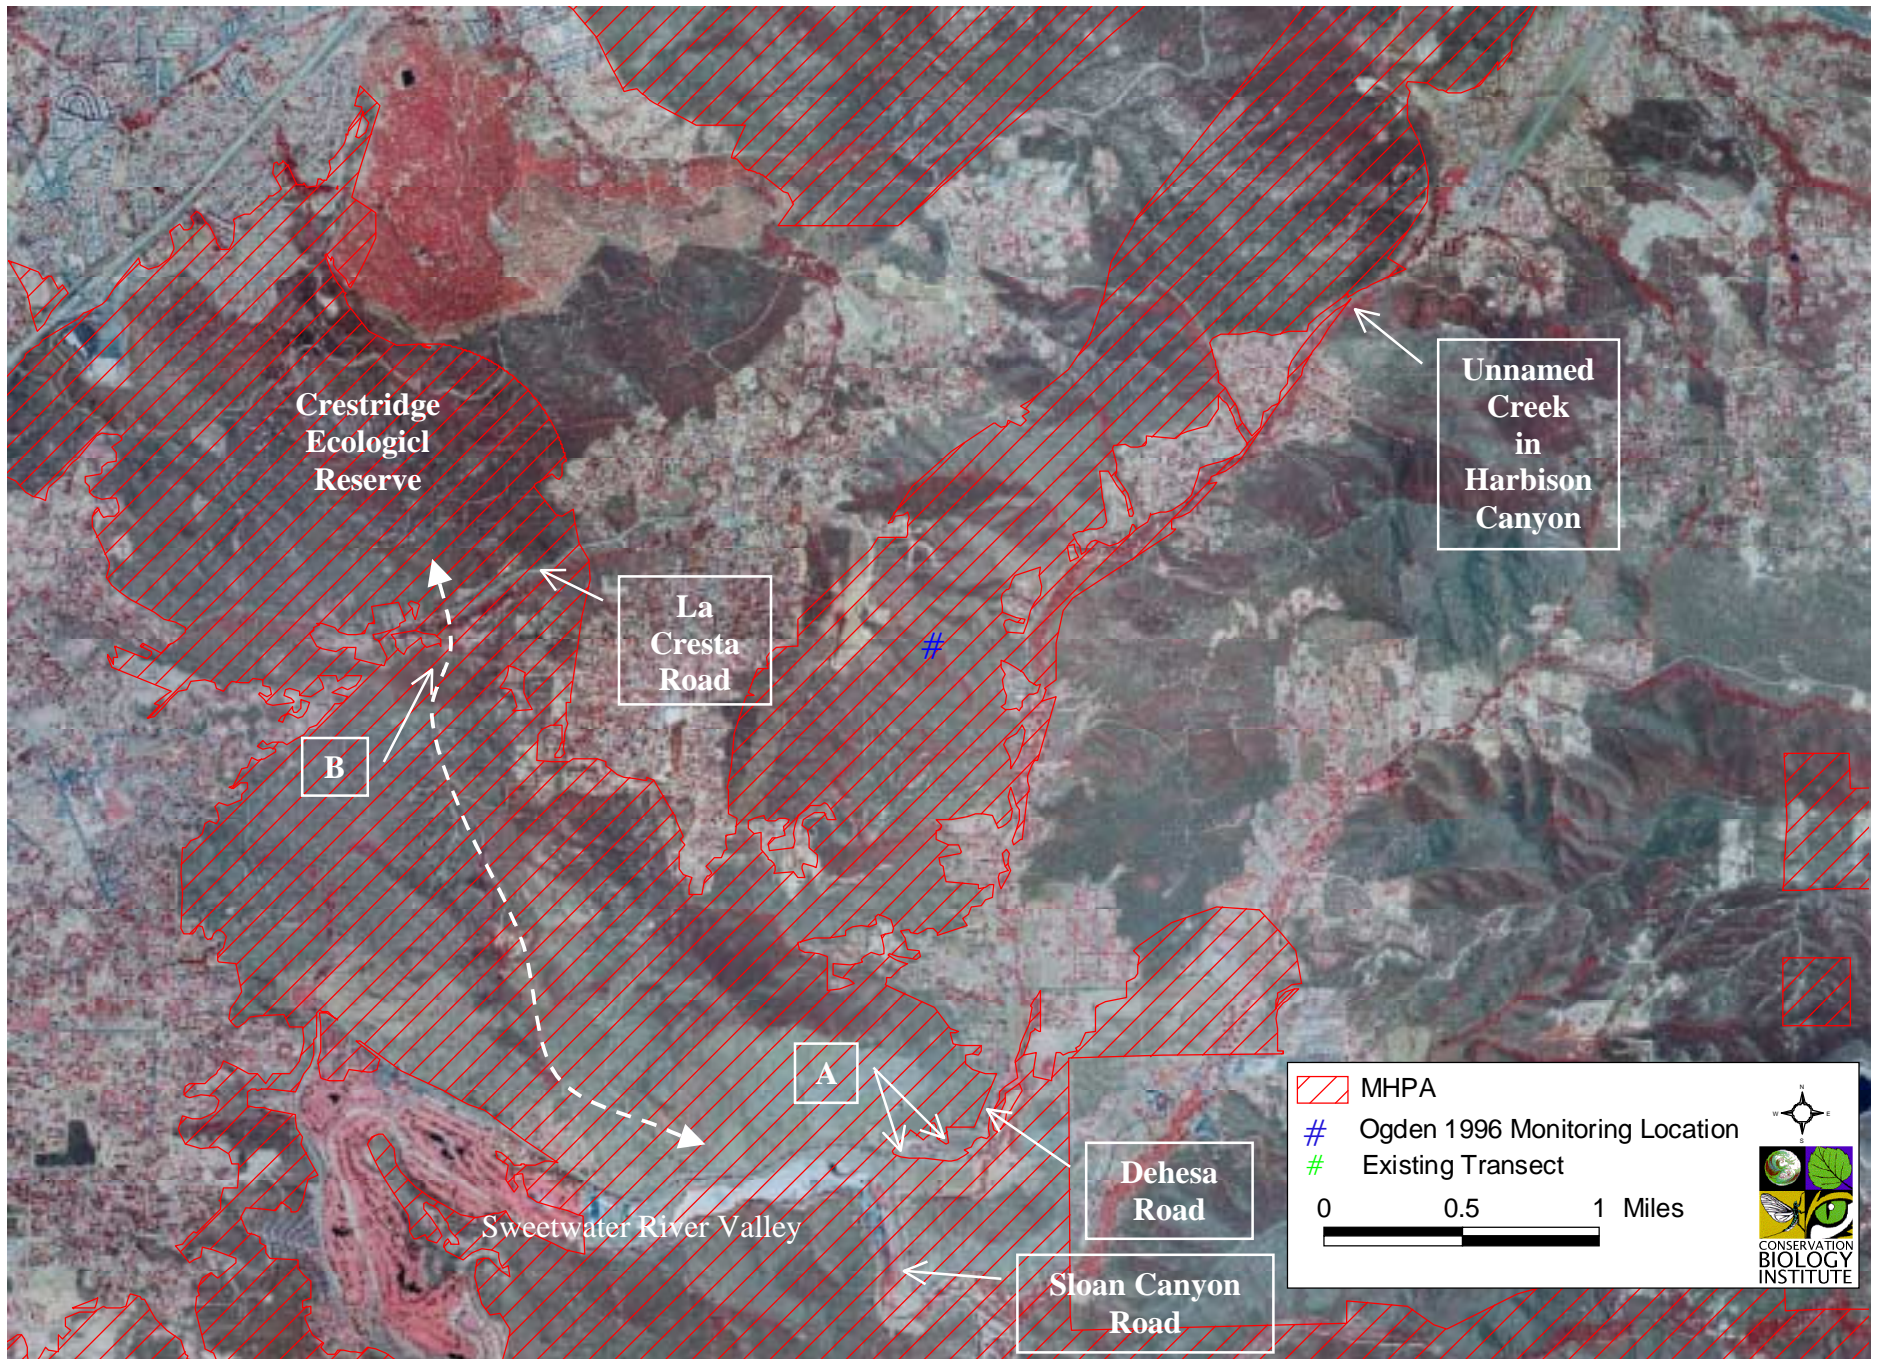
Figure L-14. Southern Harbison Canyon. **A** – Dehesa Road at Elementary School and **B** – transmission line corridor north of Dehesa Road.

Additional Location. There is the potential for wildlife movement between Crestridge and the Sweetwater River Valley (CBI 2002c) along the transmission line easement north of Dehesa Road and south of La Cresta Road (Location B, Figure L-14). Existing development and La Cresta Road probably are impediments to wildlife movement. This area is currently under private ownership but is within the acquisition boundary of the Otay-Sweetwater National Wildlife Refuge. CBI recommends placing a wildlife corridor monitoring location in the chokepoint of this area in the future, south of La Cresta Road, if development patterns and ownership allow.

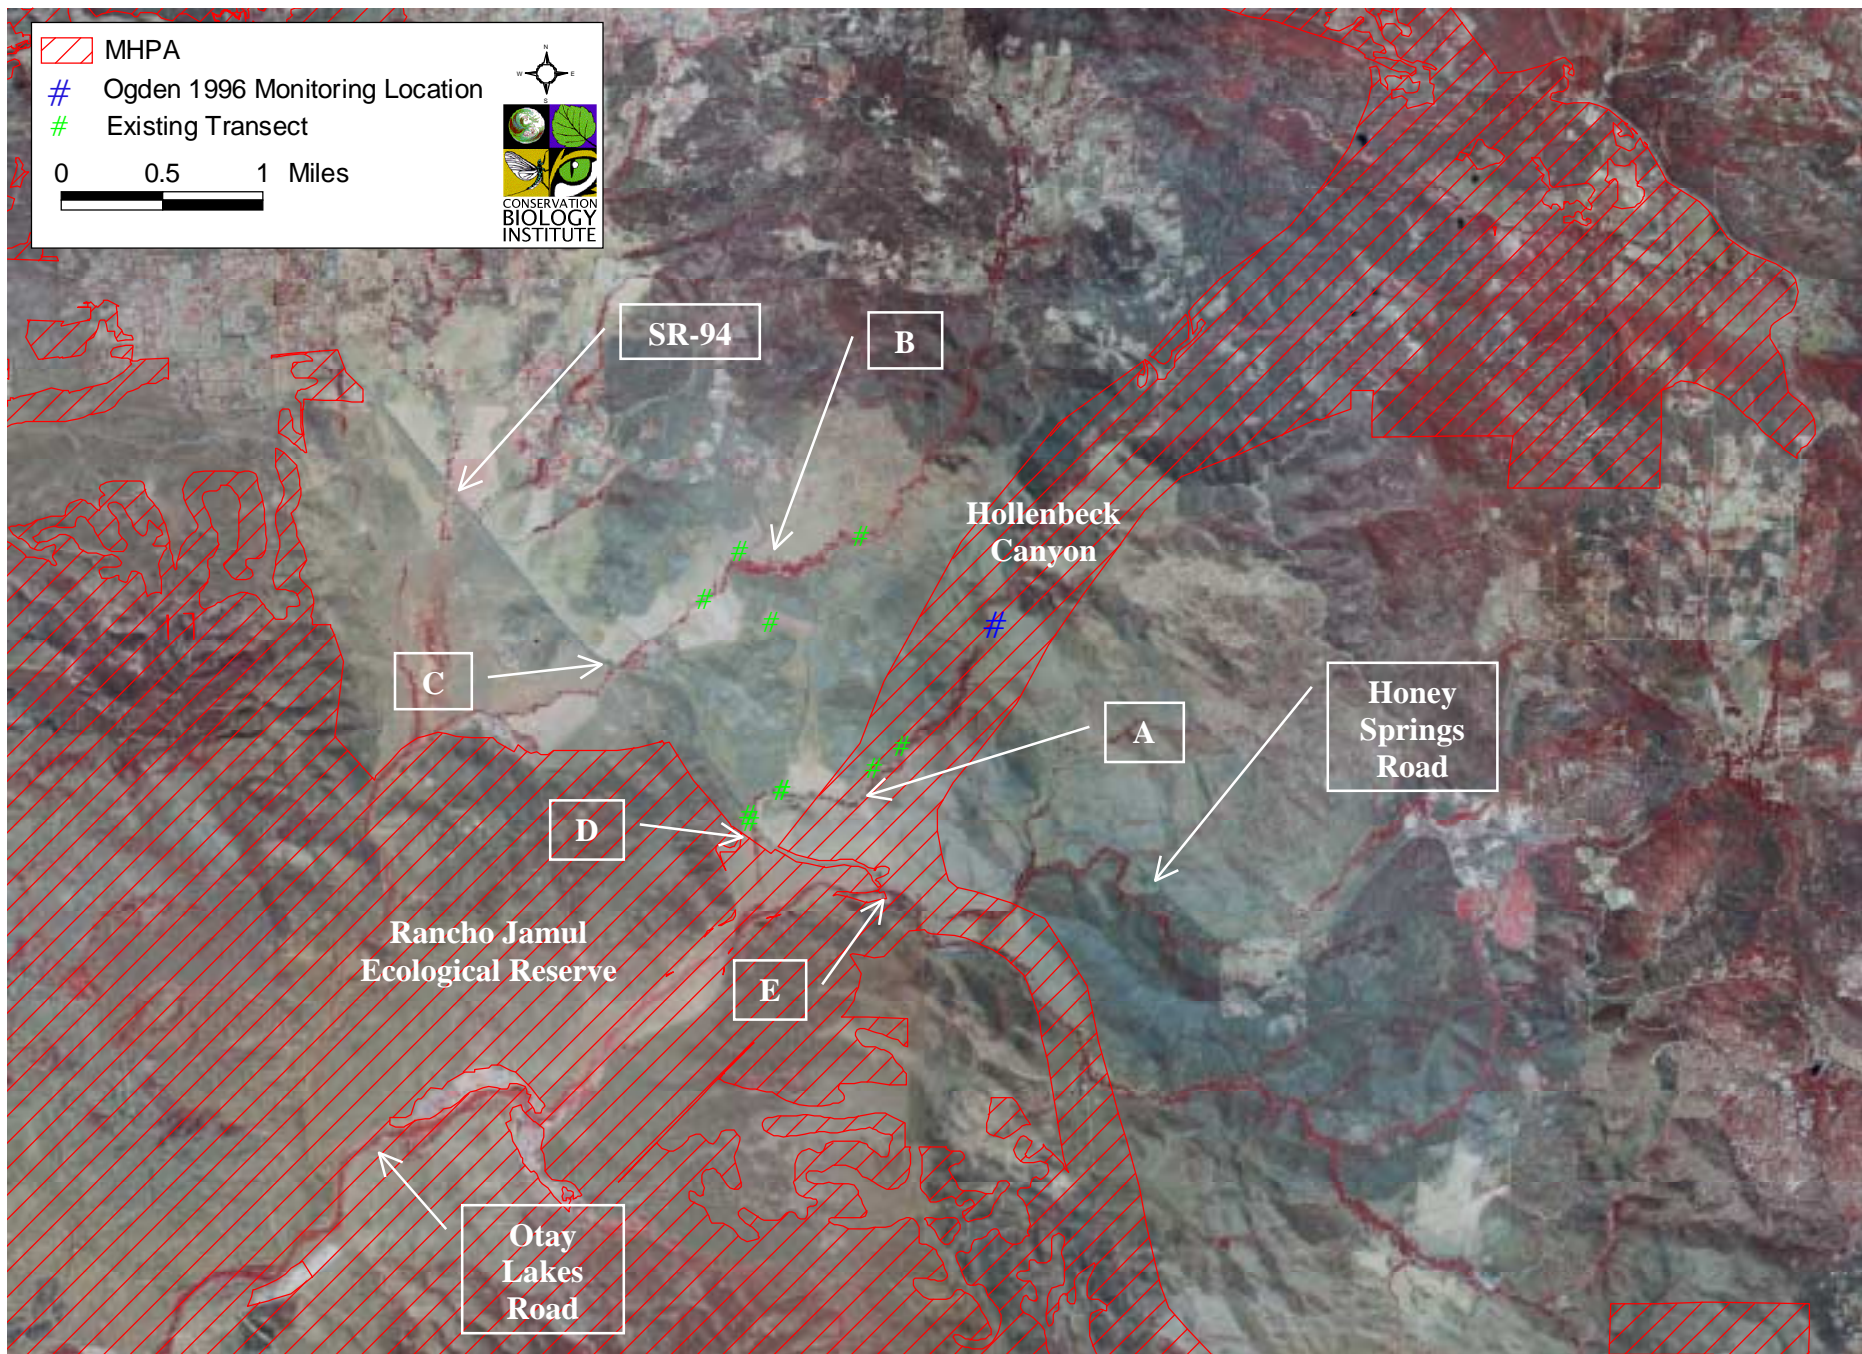
Figure L-18. Hollenbeck Canyon. **A, B** – SDTT transects in Hollenbeck Canyon preserve area, **C** - Jamul Creek culverts at SR-94, **D** - Hollenbeck Canyon culverts at SR-94, and **E** – SR-94 bridge at Dulzura Creek.

Additional Locations. The Rancho Jamul and Hollenbeck Canyon reserves are bisected by SR-94, which is heavily used through this area. The highway is fenced along both sides by a combination of barbed wire, chain link, and mesh fencing. There are at least five locations between Jamul and Otay Lakes Road where wildlife could move under SR-94 or cross at-grade. CBI recommends establishing transects at three of these locations, in combination with collecting road-kill data along SR-94 (Figure L-18):

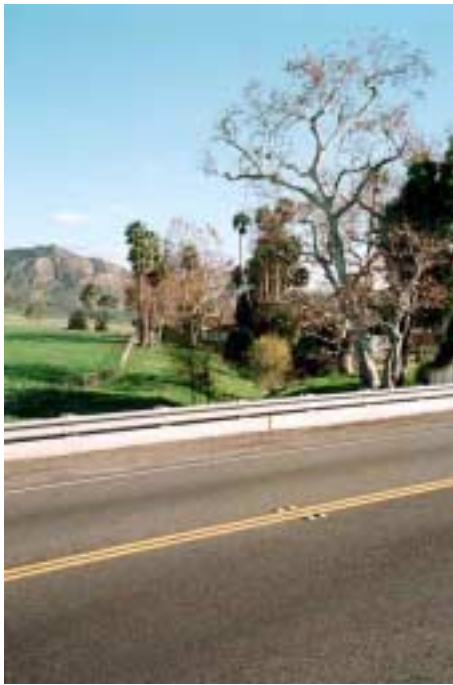
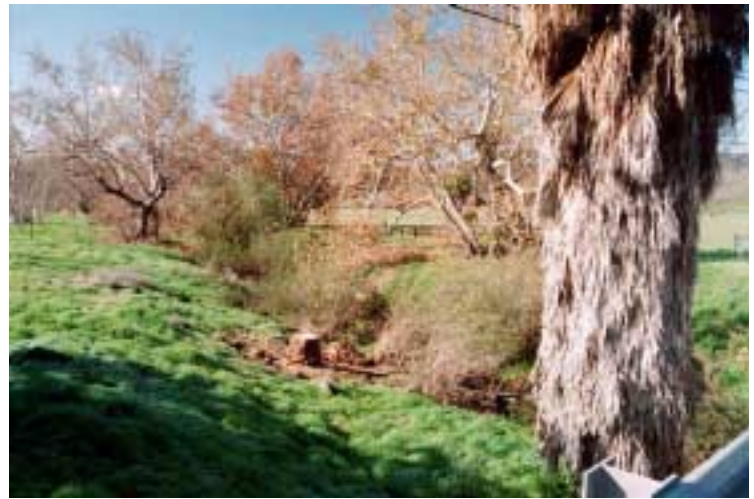
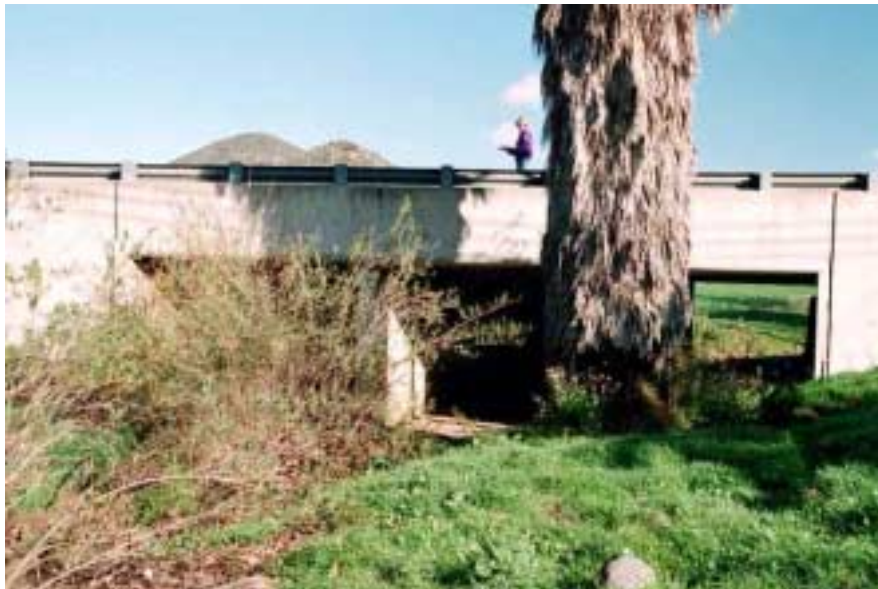
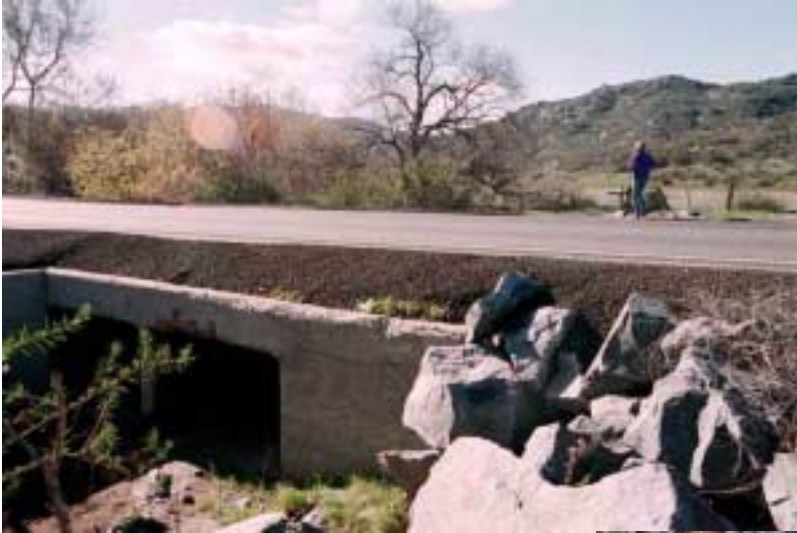
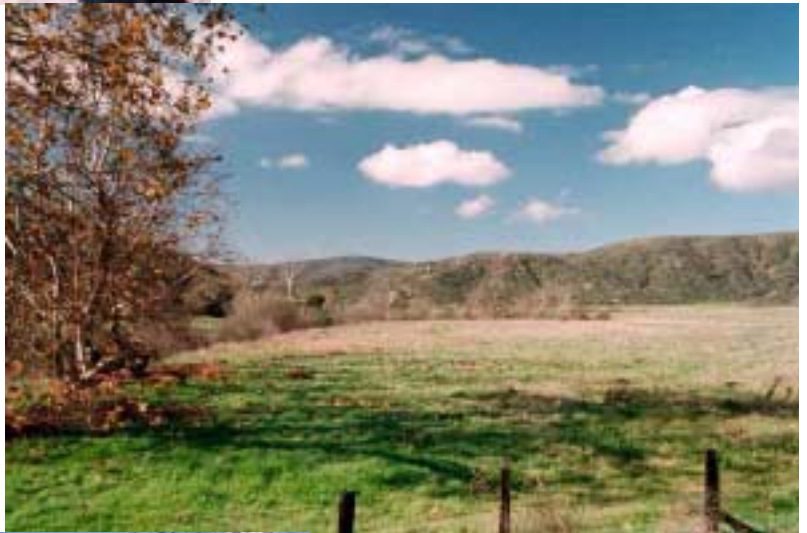
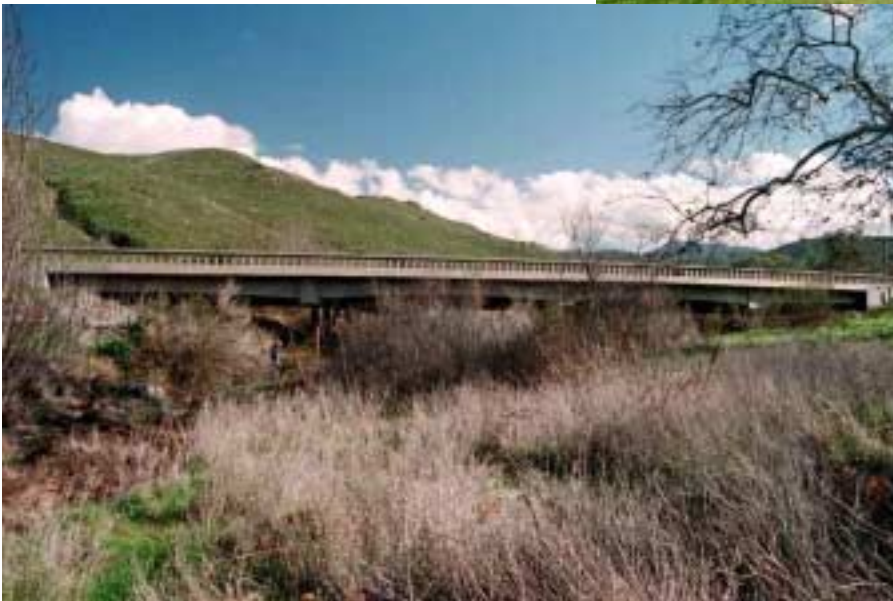
Photo L-18. Hollenbeck Canyon, Location D—Hollenbeck Canyon drainage culvert, and Location E—SR-94 bridge over Dulzura Creek.

Looking north up Jamul Creek from SR-94 bridge.

Looking south down Jamul Creek from SR-94 bridge.

SR-94 bridge over Jamul Creek, looking north.

Hollenbeck Canyon drainage culvert under SR-94 looking south.

Looking west from SR-94 bridge along Dulzura Creek.

SR-94 bridge over Dulzura Creek, looking east from downstream side.

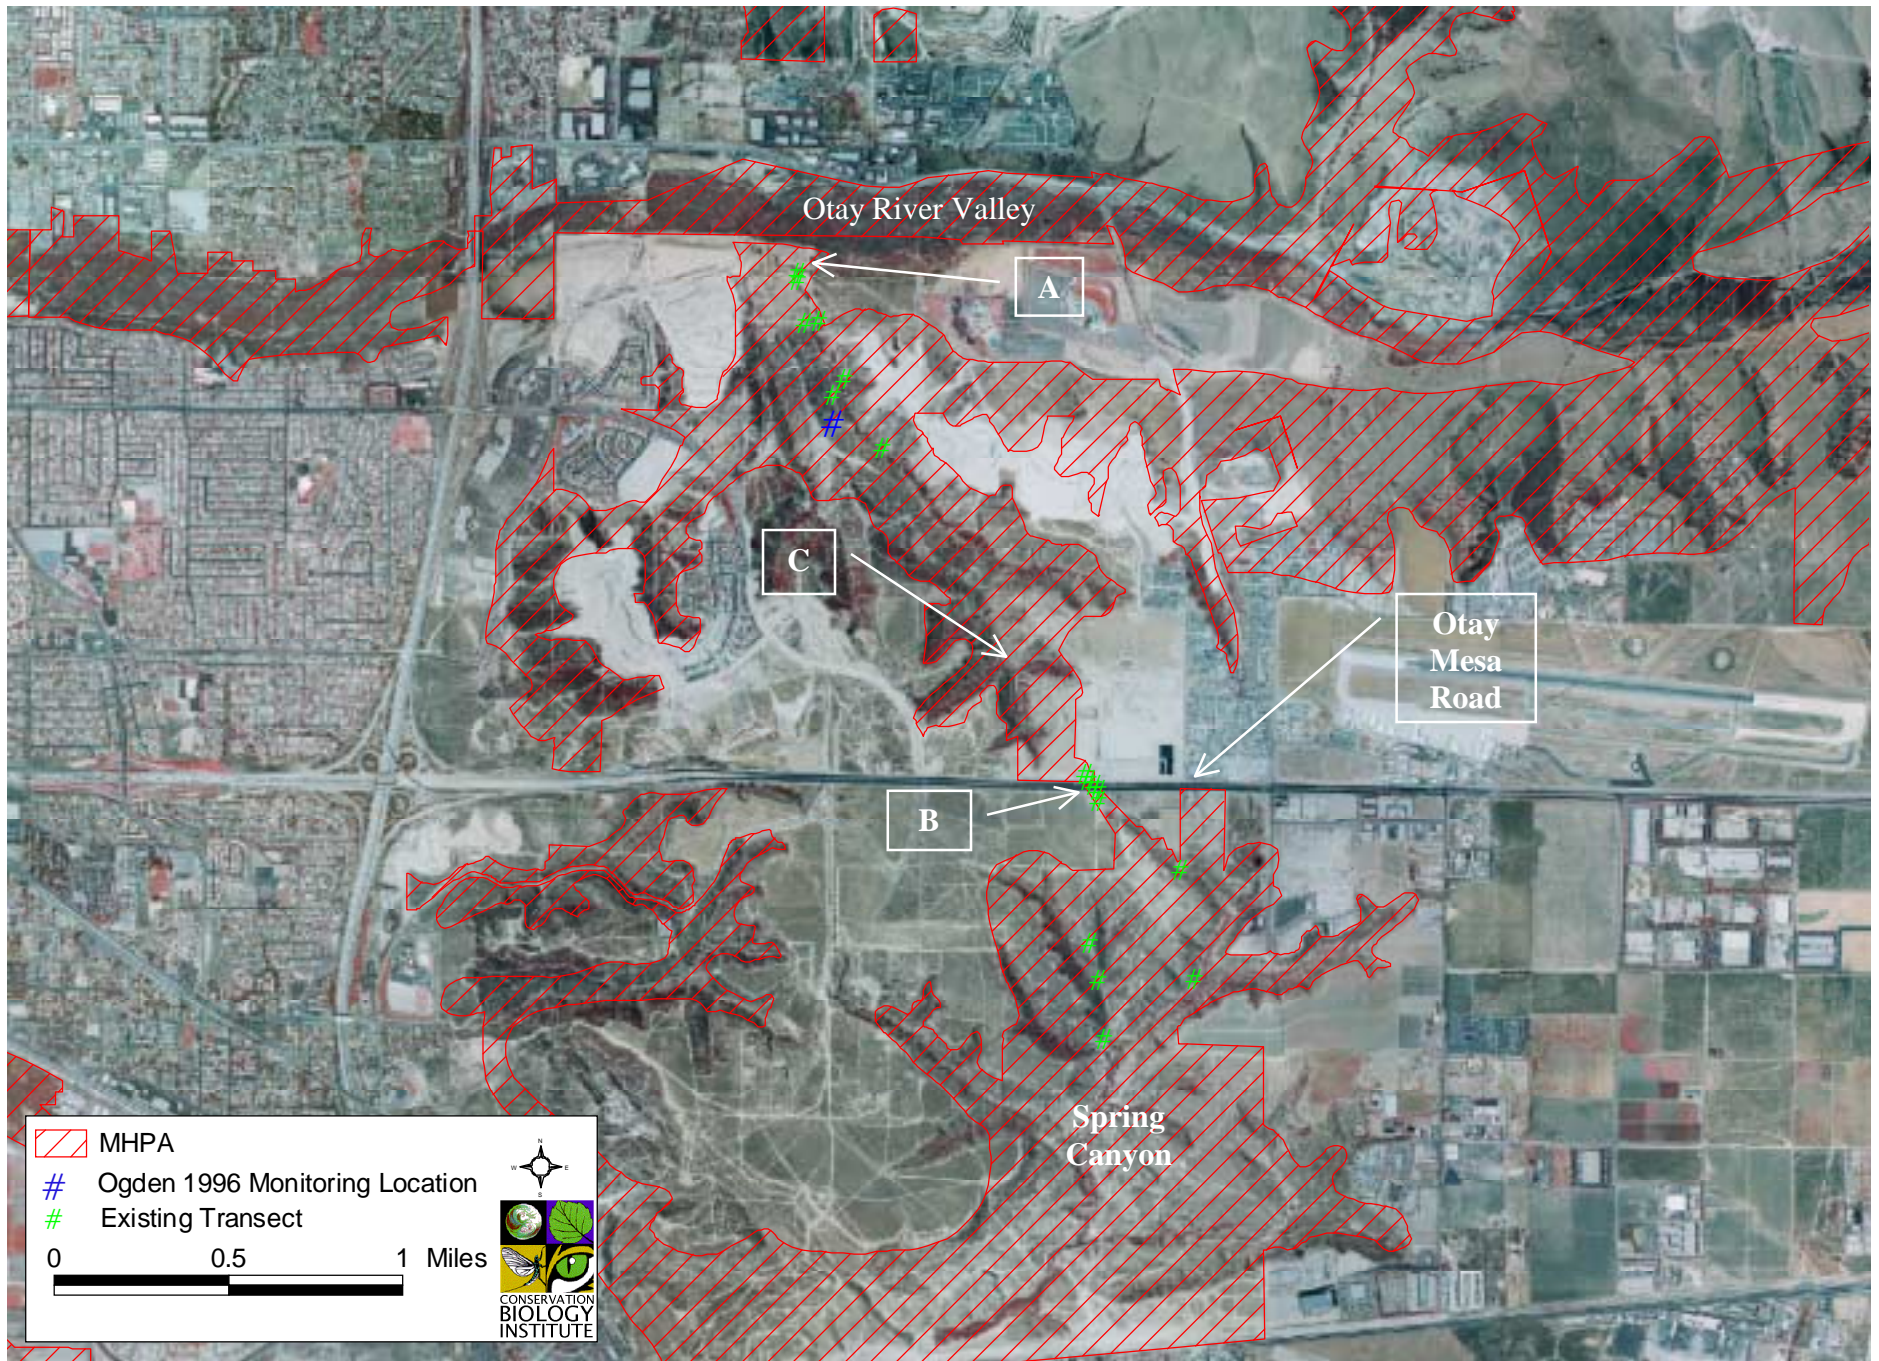
Figure L-22. Otay River Valley - West Otay Mesa (Dennery Canyon). **A** – mouth of Dennery Canyon at new road, **B** – culvert under Otay Mesa Road, and **C** – upper Dennery Canyon.

Additional Locations. CBI recommends that additional monitoring be conducted in Dennery Canyon, both at the mouth of the canyon at the Otay River Valley (Location A, at the new road) and at the upstream end of the canyon (Location C) (Figure L-22), once access is allowed.
