REVIEW OF REGIONAL HABITAT LINKAGE MONITORING LOCATIONS

Multiple Species Conservation Program

January 2003

California Department of Fish and Game
NCCP Local Assistance Grant #P0050009

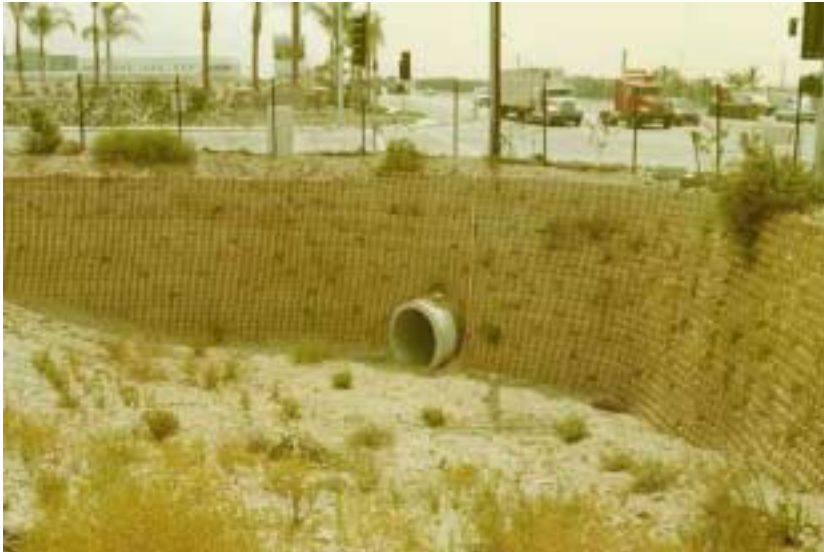
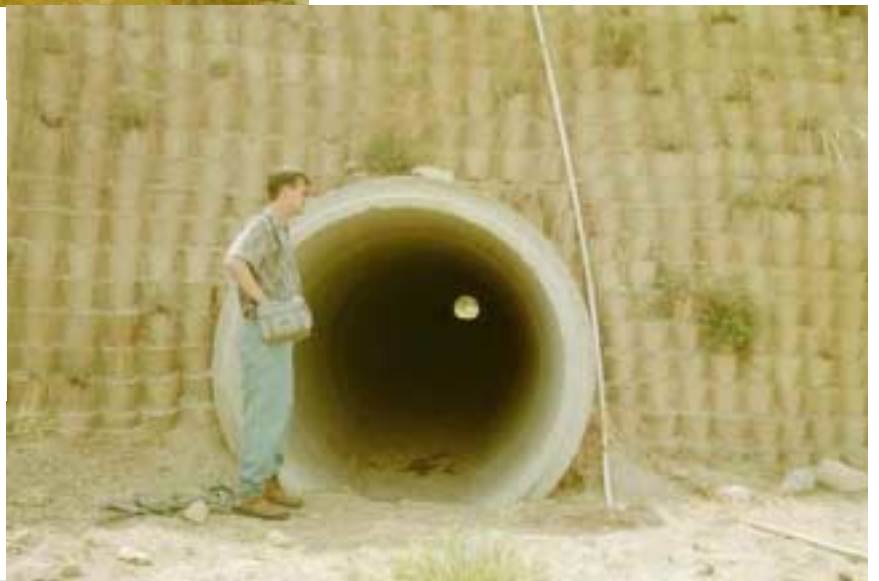
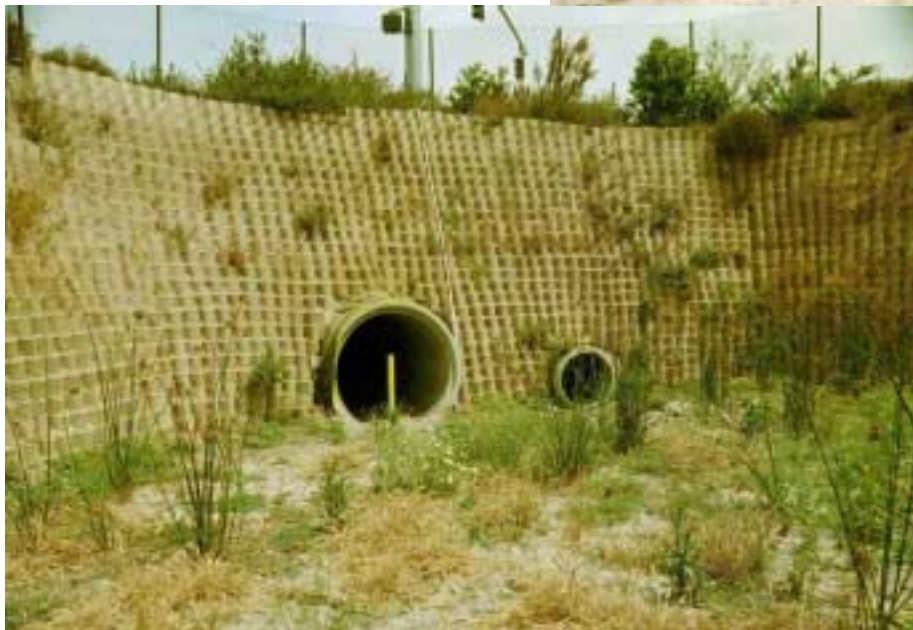
Culvert under Otay Mesa Rd. from the north side of the culvert, looking east.

Culvert under Otay Mesa Rd from the south side looking north.

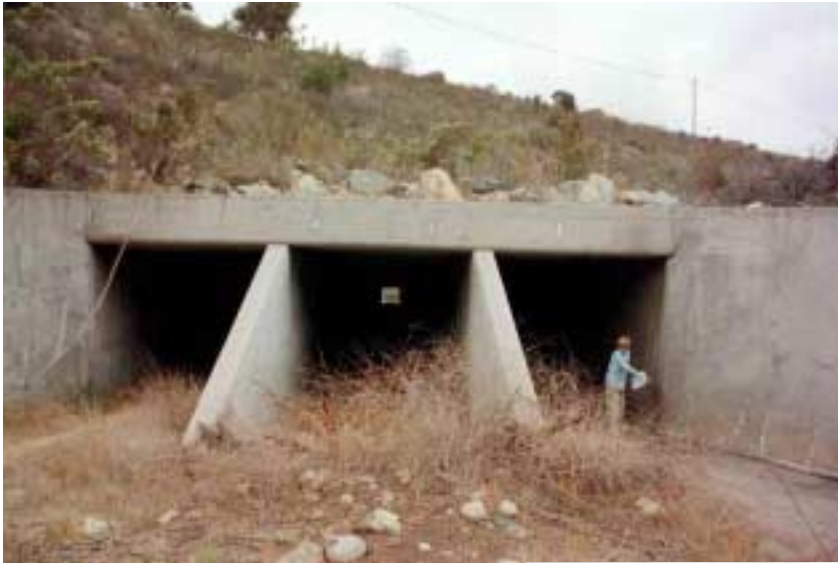
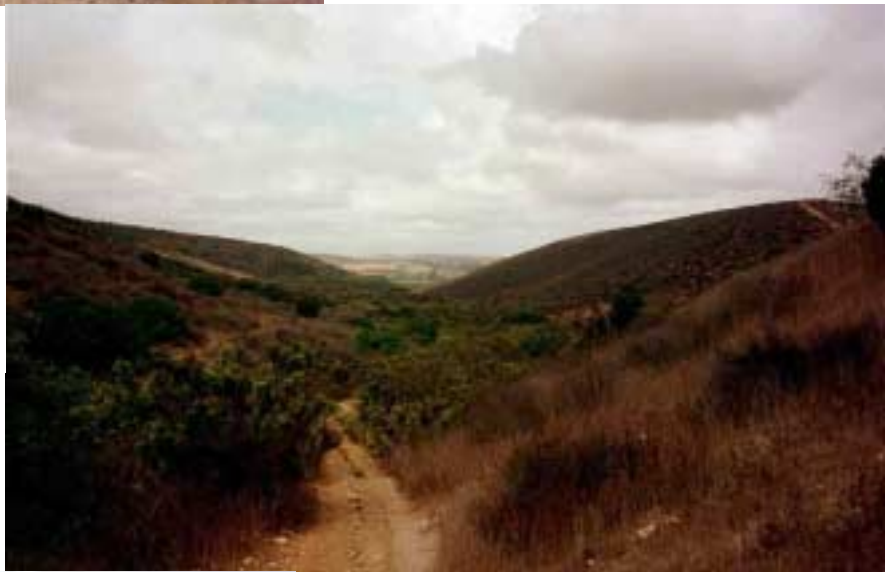
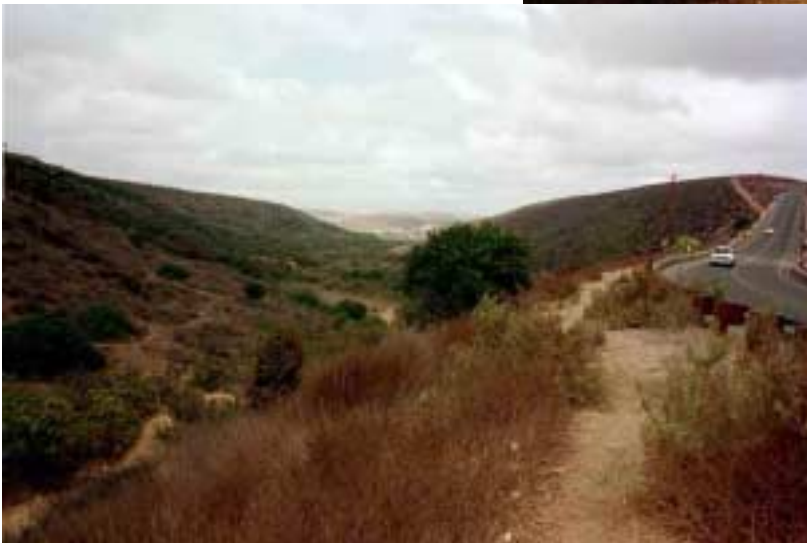
O'Neal Canyon culverts under Alta Rd looking northwest (downstream).

O'Neal Canyon west of Alta Rd looking northwest (downstream) towards Otay River Valley.

O'Neal Canyon looking northwest towards Otay River Valley. Alta Rd in the right side of photo.

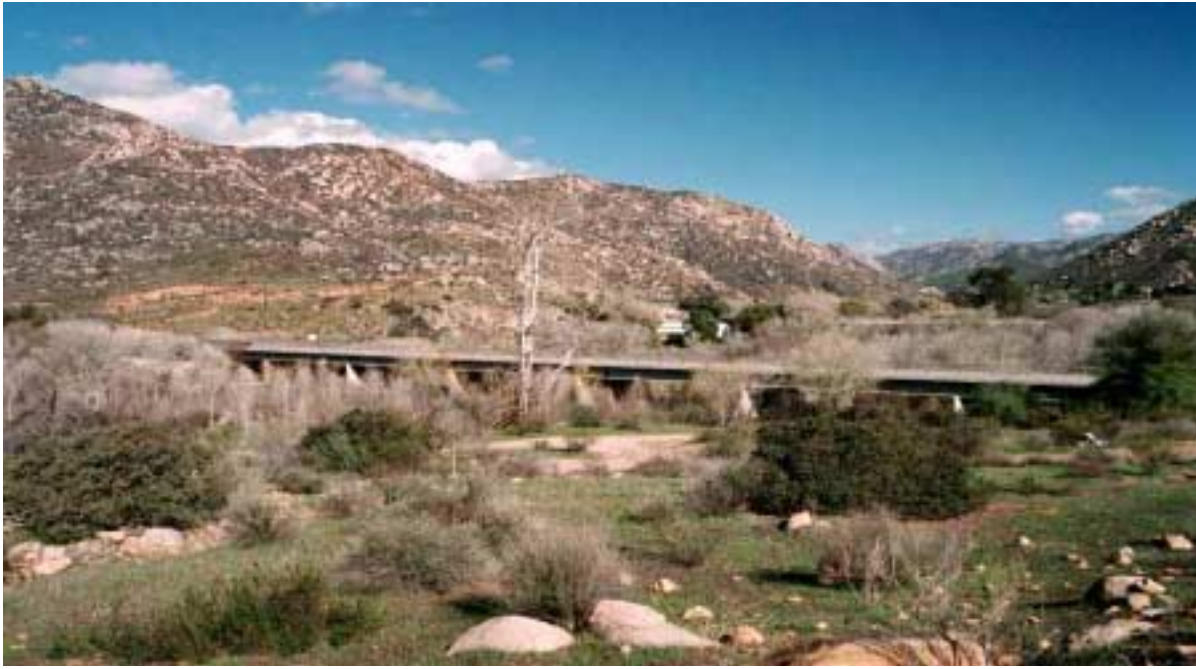
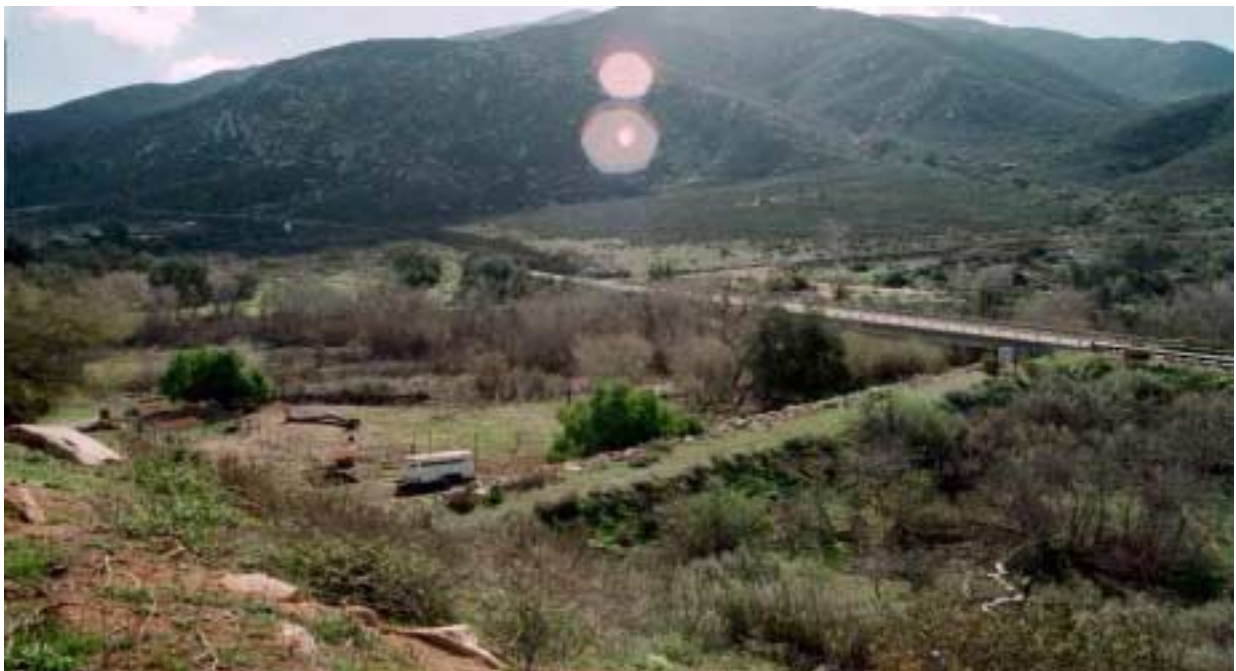
Photo L-28. San Ysidro Mountains East, SR-94 bridge over Cottonwood Creek.

SR-94 bridge over Cottonwood Creek looking north from south and west side of bridge.

SR-94 bridge over Cottonwood Creek looking south from north and east side of bridge.

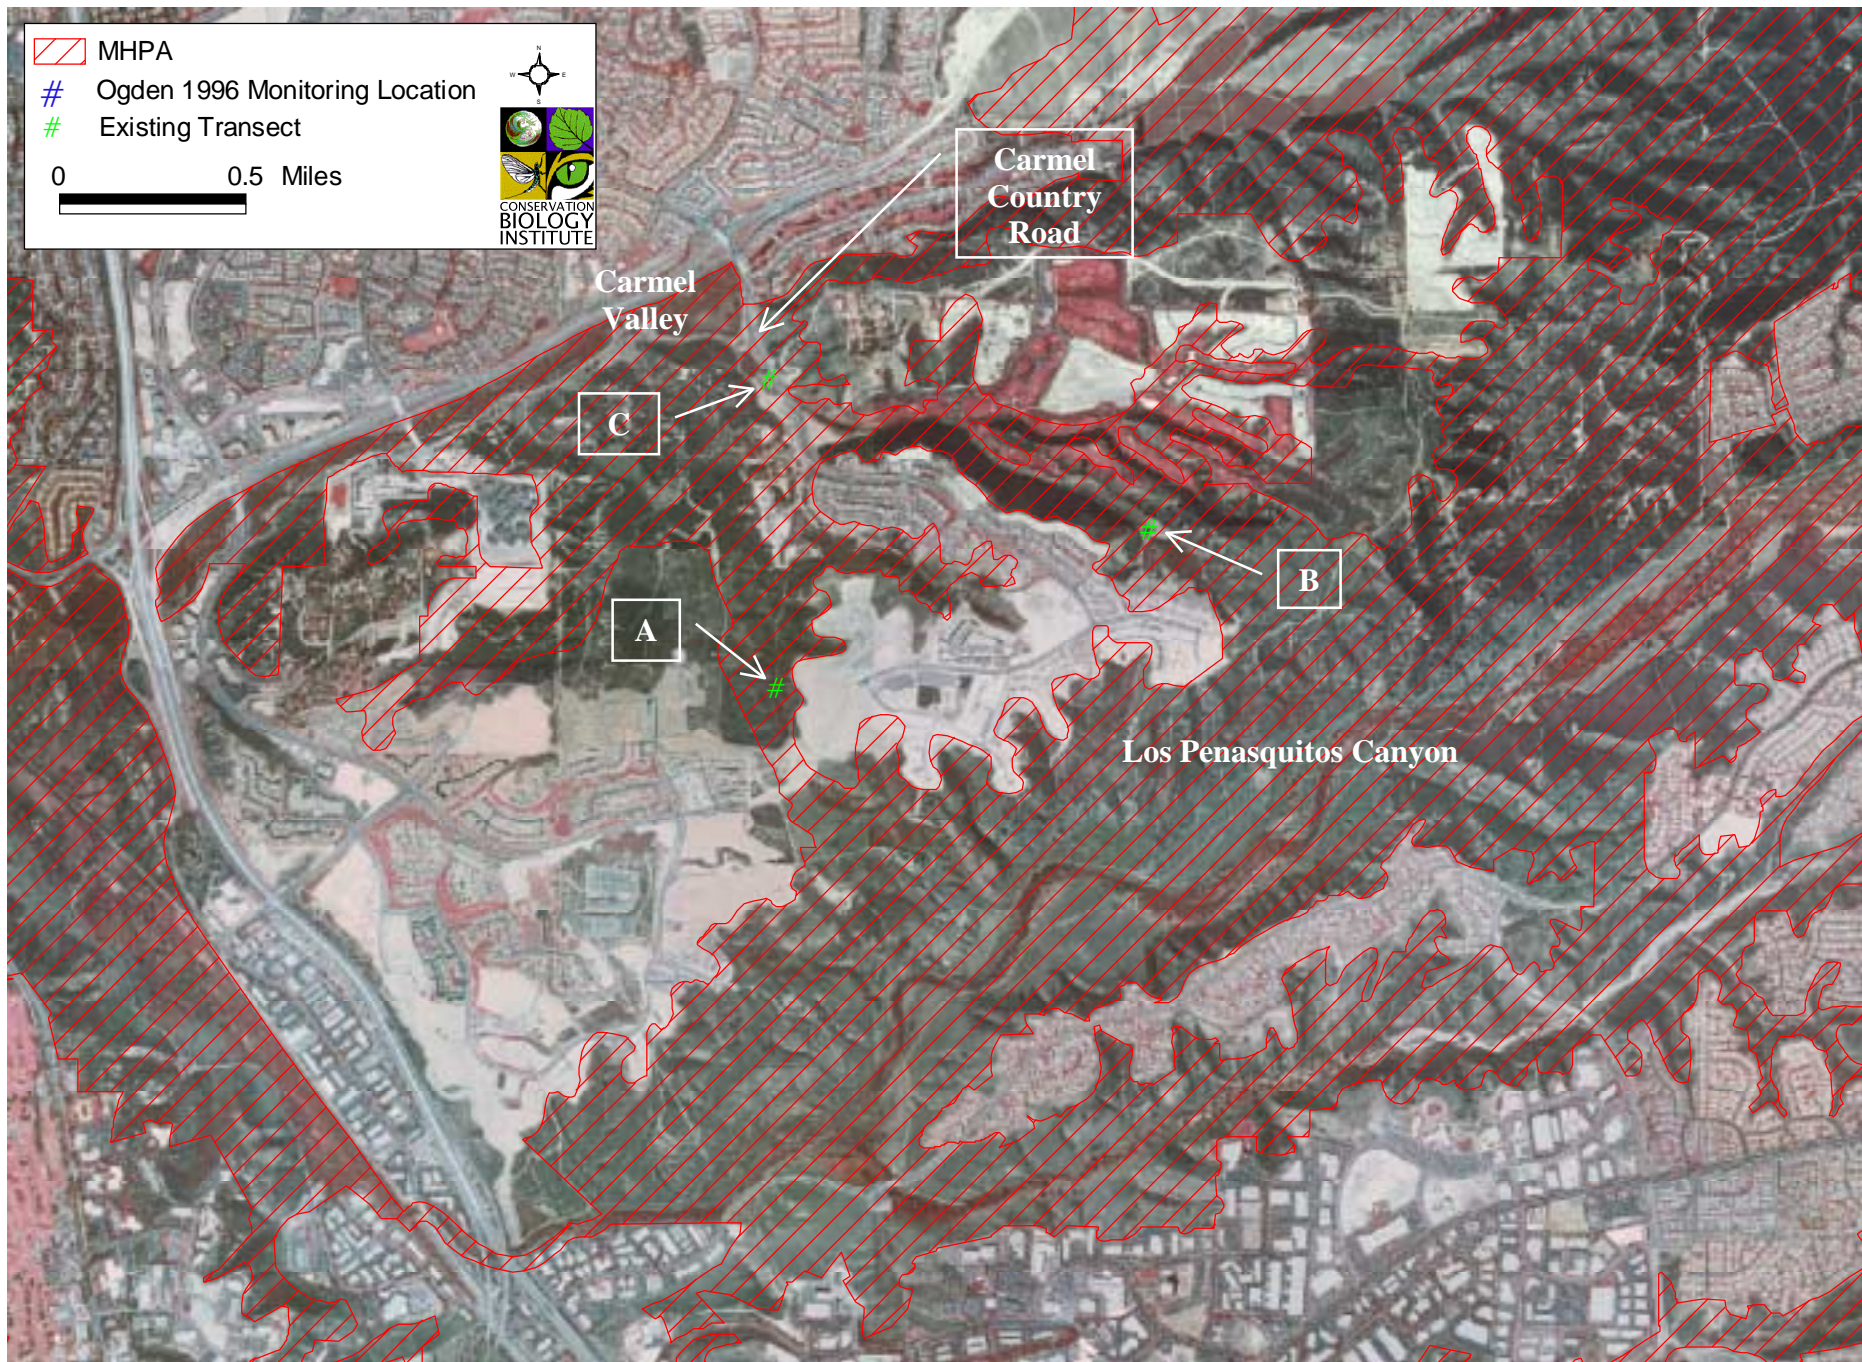
Figure L-30. Del Mar Mesa. **A** – Little Shaw Valley, **B** – Big Shaw Valley, and **C** – lower Shaw Valley (culverts under Carmel Country Road).

Del Mar Mesa serves as a habitat connection between Los Peñasquitos Canyon and Carmel Valley. CBI (2002b) established and monitored three transects at chokepoints on Del Mar Mesa in 2001 and 2002: Little Shaw Valley (Location A, Figure L-30), Big Shaw Valley (Location B), and the lower Shaw Valley (culverts under Carmel Country Road, Location C). CBI recommends continued monitoring at these transects.

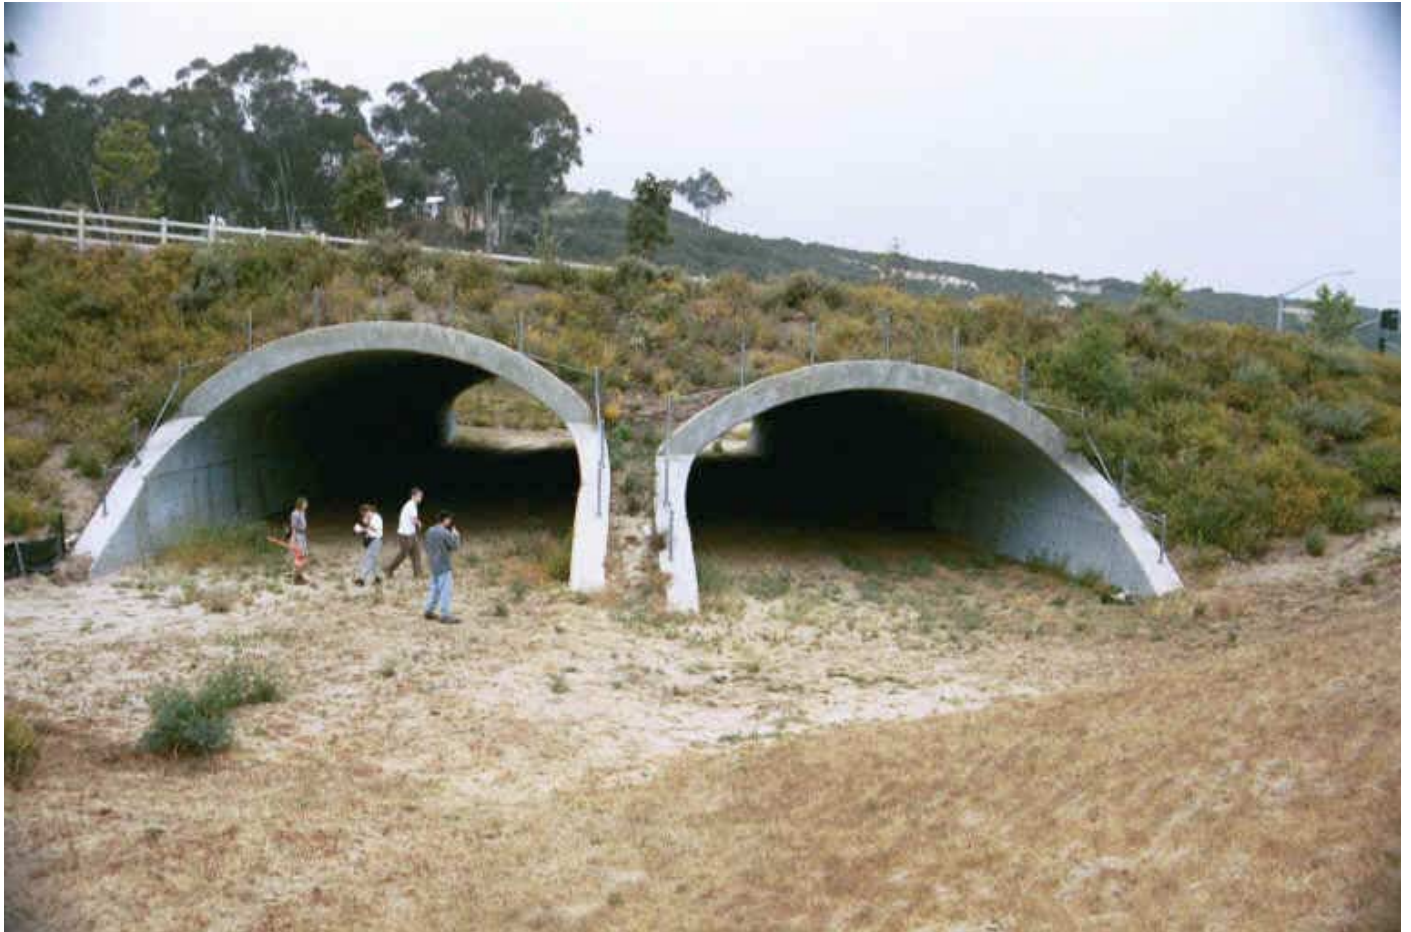
Photo L-30. Del Mar Mesa, Location C—Lower Shaw Valley.

Culverts under Carmel Country Rd in lower Shaw Valley looking west.
